Los Alamos National Laboratory Plutonium Facility (PF-4) Seismic Safety

October 22, 2014

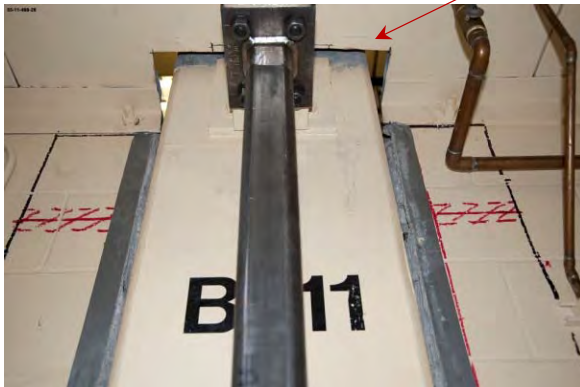
2011 modifications addressed confinement weak-links

- Mezzanines above the main floor were strengthened
- Ventilation component pads were reinforced
- Over-constrained basement columns were released
- Ceilings of basement ventilation plenum rooms were reinforced

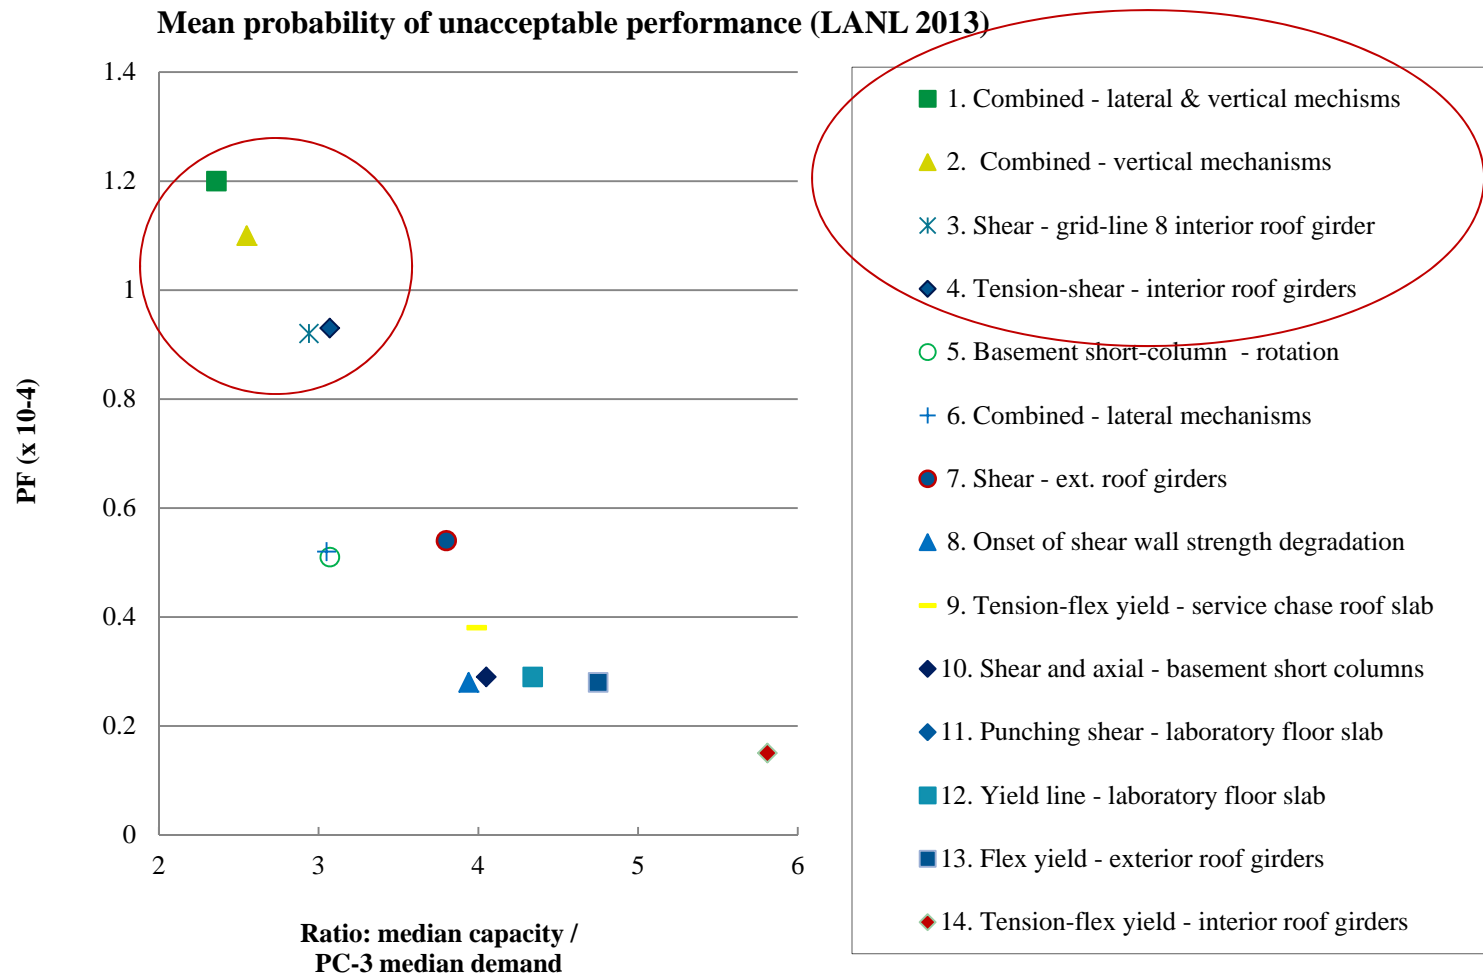
2013 Update – girders are the dominant failure mode

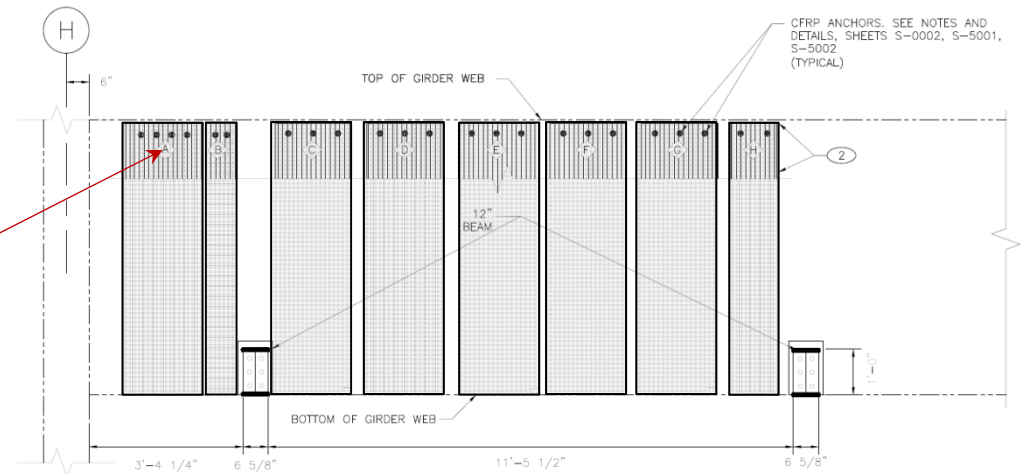
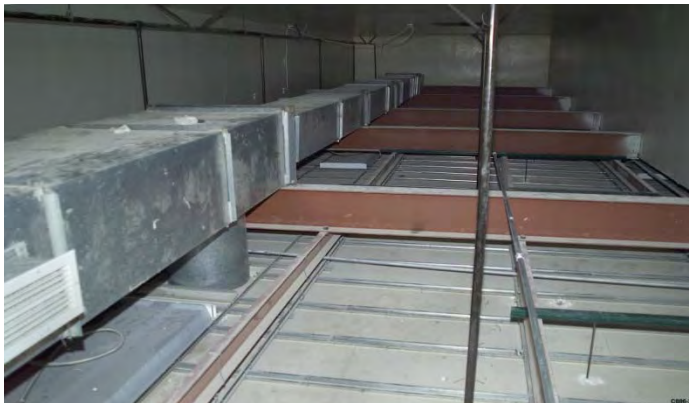
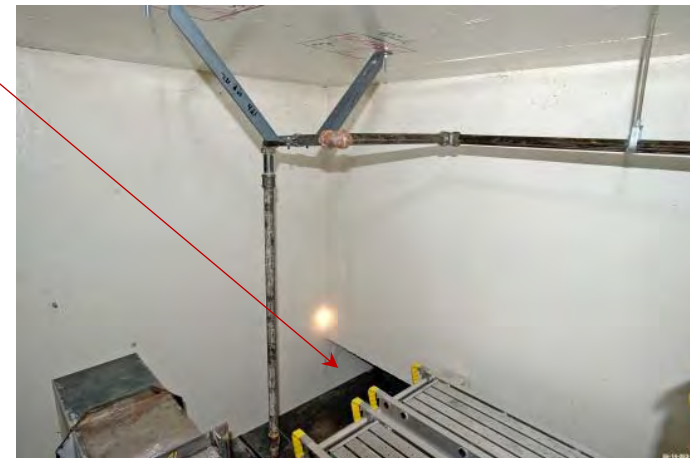
Design of girder modification is complete

- The modification consists of layers of carbon-fiber reinforced polymer (CFRP) where the girder meets the central wall (the H-wall)
- In addition to surface adhesion, the layers will be anchored at the top
- Minimal space for wrapping under girder
- Difficult access and interferences complicate work in the attic
