Accident Investigation Report

Phase 2 Radiological Release Event at the Waste Isolation Pilot Plant, February 14, 2014

April 2015

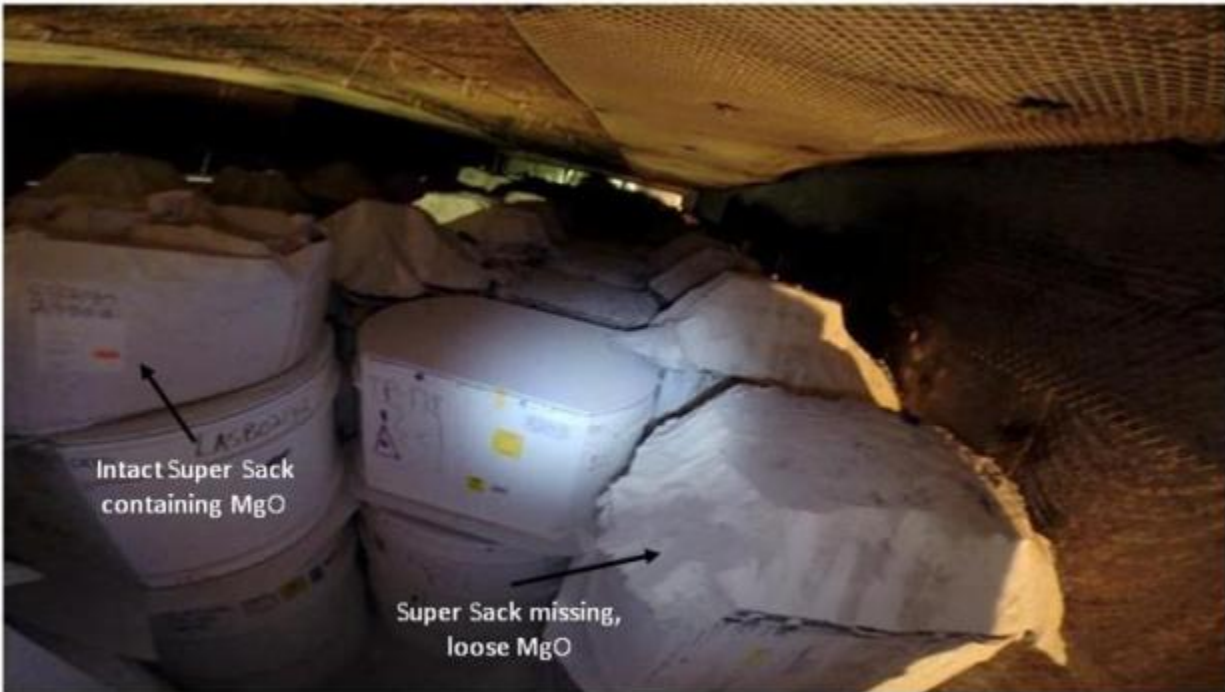
Figure 2-2: Missing Super Sacks Leaving Loose Piles of MgO on Waste Stacks

Photographic evidence of Panel 7 Room 7 from re-entries shows that 17 of the MgO super sacks were damaged. The super sack fabric and stiffener material (cardboard) was damaged or missing as illustrated in Figure 2-2, which allowed MgO to fall between waste stacks and left partial sloped piles of material on top of and between the waste stacks.

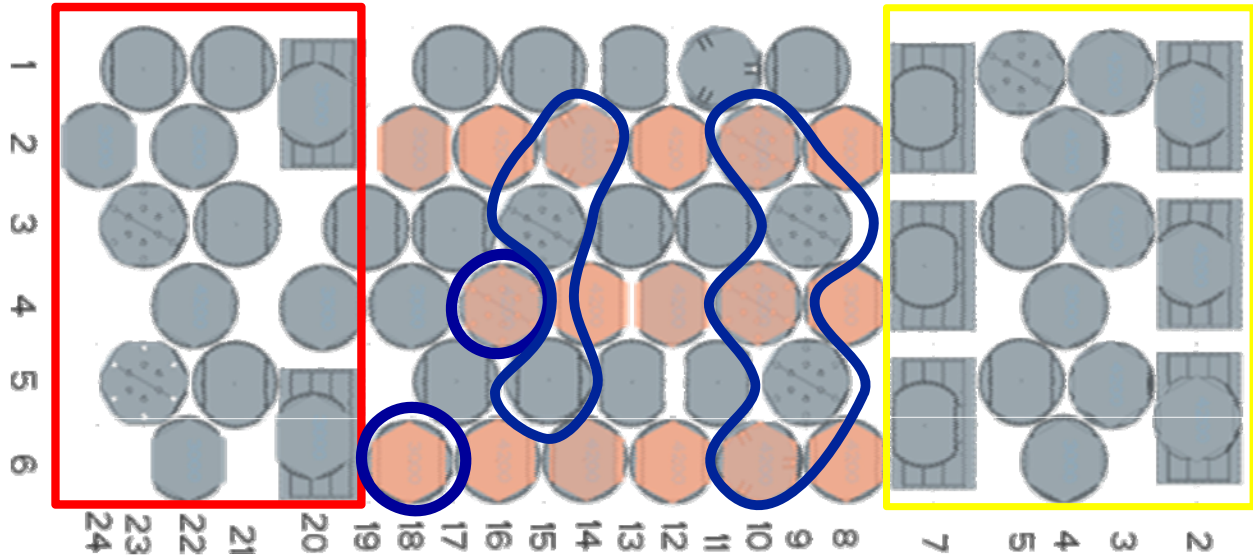
The visual inspections found evidence of slight localized discoloration of the Panel 7 Room 7 south rib (wall) that was the result of fire exposure. There were no such discolorations of the north rib, back (overhead), or bulkhead and no significant accumulations of soot on these three surfaces. This evidence indicates that flashover in Room 7 did not occur. The inspection demonstrated that the primary fire damage was intermittently dispersed in the array between Rows 8 through 18 (Figure 6-2). No physical damage was evident for waste containers in Rows 2 through 7 (yellow box in Figure 6-2), or Rows 19 through 24 (red box in Figure 6-2). The most significant damage occurred in the regions marked in blue on Figure 6-2.

NOTE: Significantly damaged MgO Super Sacks shown in peach.

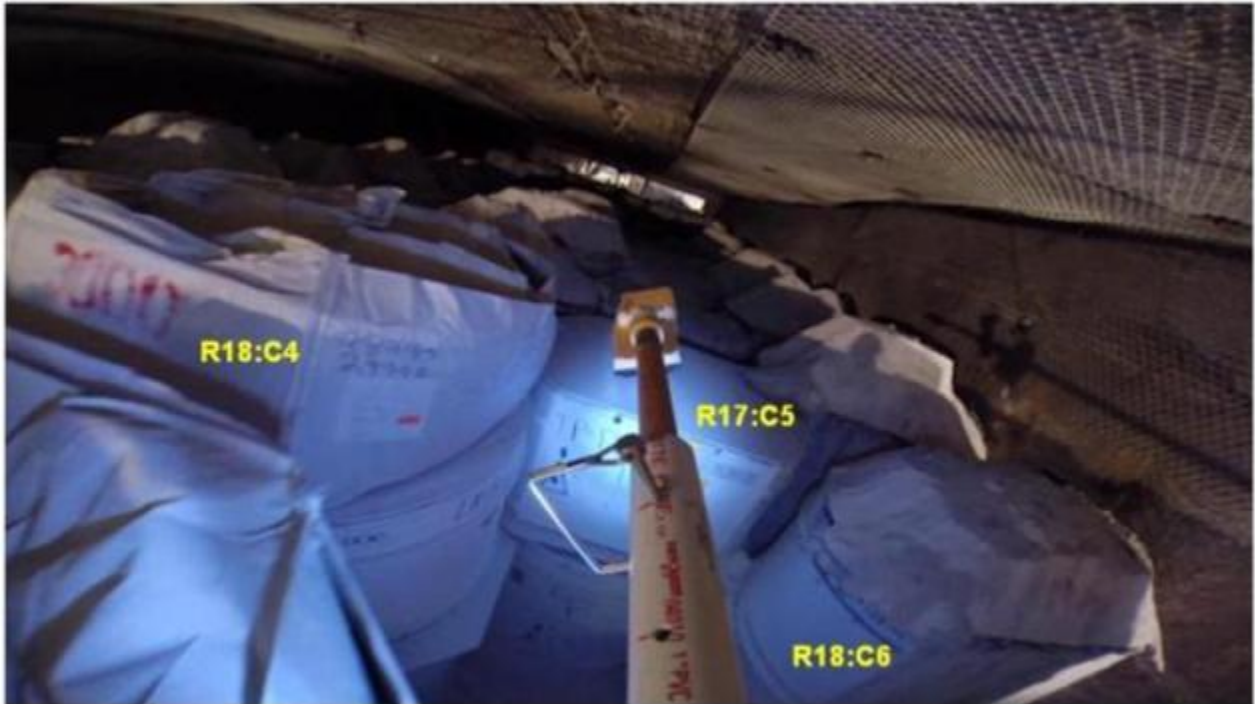
Figure 6-4: Panel 7 Room 7 Array, Columns 4 through 6

The MgO super sacks from Rows 8 through 18 were damaged. The polypropylene fabric that formed the sacks was severely damaged or missing from most of these locations. The fabric damage could have been caused by melting or ignition (Figure 6-4). Polypropylene is categorized as an easy-to-ignite material with a melting temperature in the range of 160°-176°C. Evidence of both mechanisms was identified during the array inspections. When the fabric was damaged, the cardboard stiffeners collapsed, the MgO flowed and formed piles of loose material at the damaged MgO super sack locations. At most of these locations the angle of repose (e.g., slope) was very steep, almost 60°, indicating gravity was the dominant force acting on the MgO after the super sacks were consumed by the fire.

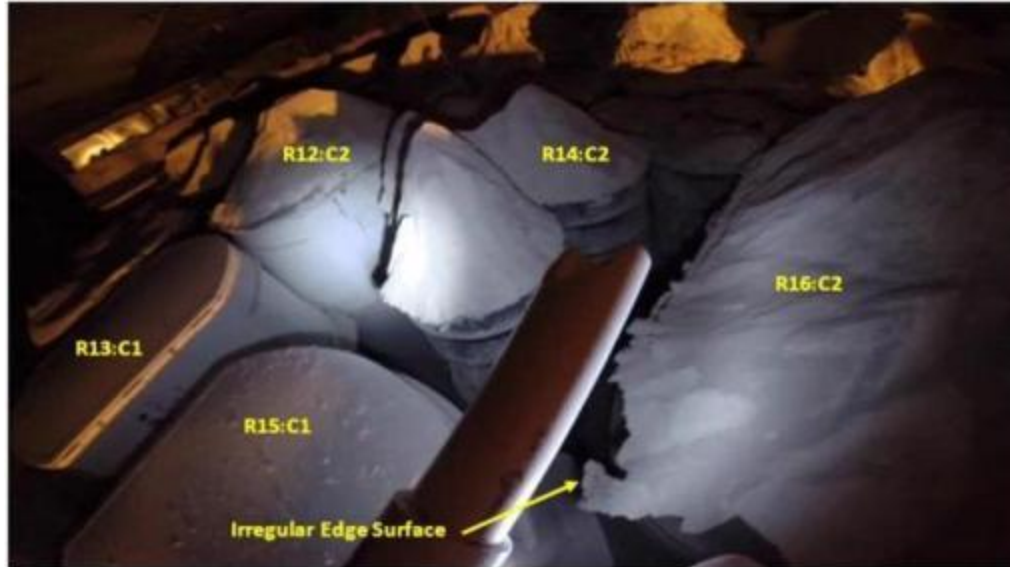
Figure 6-5: Evidence of Irregular Edge Surfaces at R16:C2

The cardboard stiffeners collapsed into multiple final orientations: hanging from a stack edge, cantilevered over the edge of a waste package, bridging between two stacks, or resting on the floor. Some of the locations where the stiffeners were cantilevered or bridging exhibited irregular edge surfaces (Figure 6-5). At R15:C5 there was a concave burn pattern in the portion of the cardboard that was cantilevered over the edge of the lid of a standard waste box (SWB) (Figure 6-6). The burn-pattern is typical of horizontal material exposed to a flame from below. Similar materials may burn as long as exposed to an external flame, but will likely self-extinguish once the flame is removed. There were also smaller cardboard remnants lying on the lid. These remnants display striations of the corrugated layer within the original cardboard matrix.

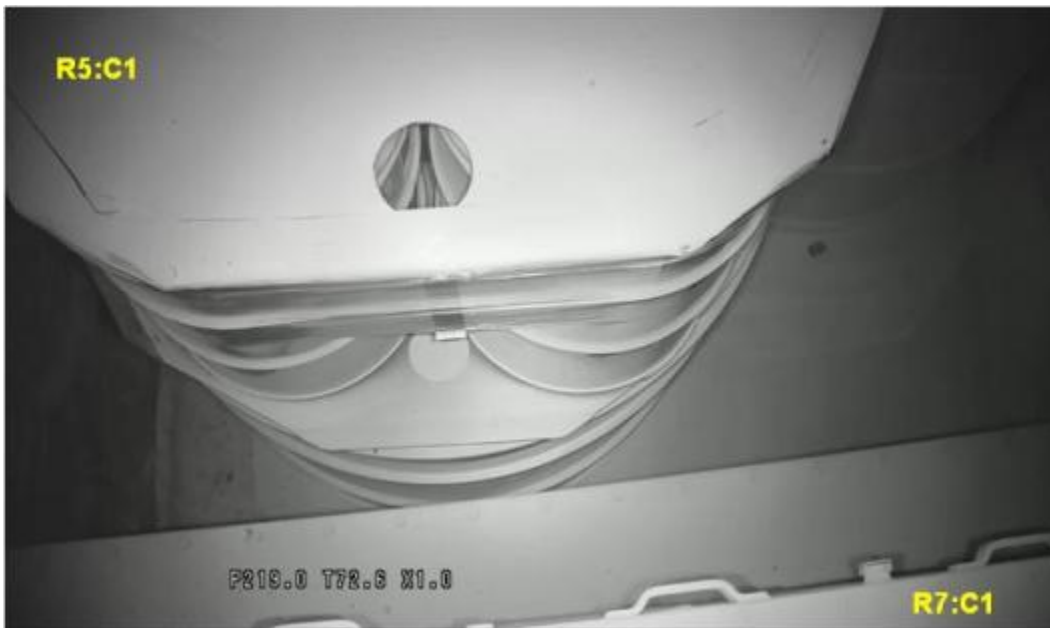
Figure 6-7: Undamaged Stretch Wrap at R5:C1

Rows 2 through 7 contained a mix of TDOPs, SWBs, 55GD assemblies, 100GD assemblies, and Standard Large Box Type 2s. These rows were closest to the bulkhead. The inspection identified no fire-related damage to the polyethylene stretch wrap or the polypropylene super sacks in these rows. The lack of damage to the polyethylene stretch wrap in these rows establishes that the bulk air temperature passing over the array was low, nominally below 135°C, which is the upper value of the melting temperature range of the polyethylene stretch wrap¹² (Figure 6-7, Figure 6-8 and Figure 6-9).

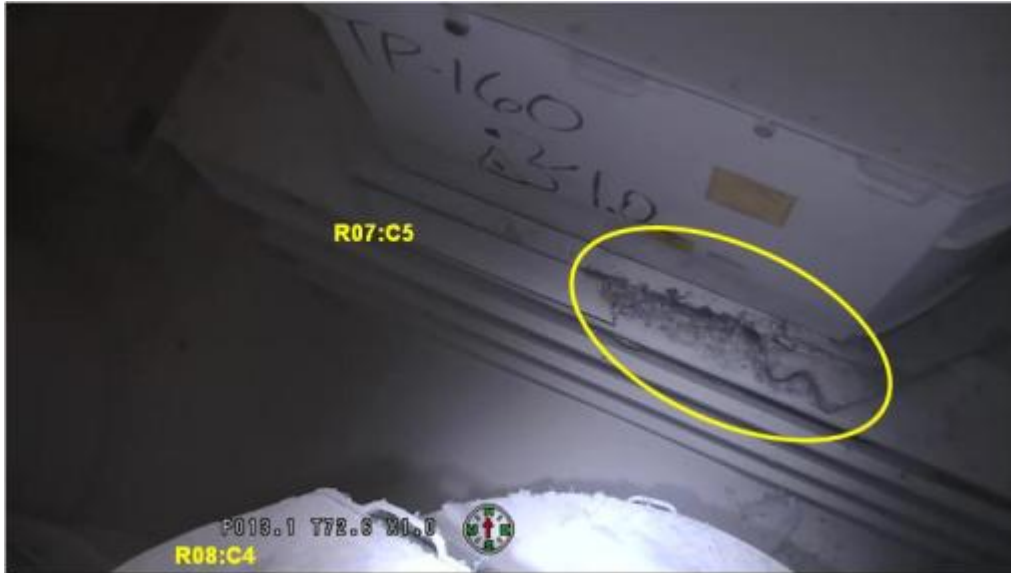
Figure 6-10: Fiberboard Slip Sheet Damage at R7:C5

Ignition of a fiberboard slip sheet did occur at R7:C5. The fiberboard charred over a short region and self-extinguished (Figure 6-10). This region is adjacent to R8:C4, which had a fire-damaged MgO super sack, so ignition could have occurred by direct thermal heat transfer from the fire at R8:C4, from impact by burning material (cardboard or fabric) falling from R8:C4, or by embers generated elsewhere in the array. Damage to this fiberboard was identified as fire damage closest to the bulkhead.

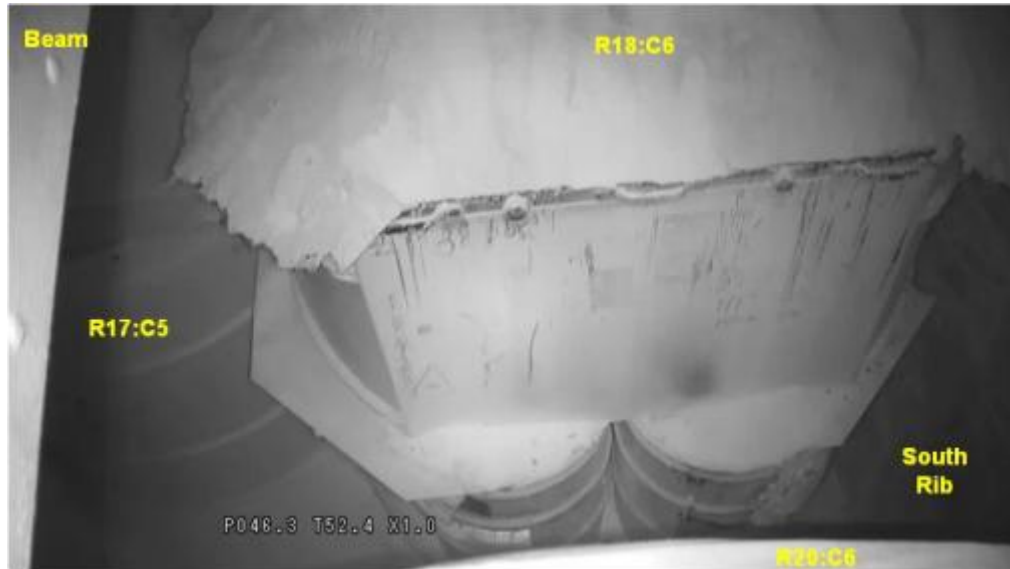
Figure 6-11: Face Side (west) of R18:C6

the middle and bottom 55GD assemblies appears to be intact although a variety of debris have accumulated on the top of the reinforcement plate. In some locations fallen material has combusted resulting in discoloration of a waste container. In one location sufficient flame exposure occurred to leave a clean burn pattern where all of the dirt, paint, and soot has burned away leaving a bright metal surface (Figure 6-13). The stretch wrap on the north-west corner of the lower tier was also damaged by flames (Figure 6-14). Except as noted, no other damage to the stretch wrap was identified in this stack.

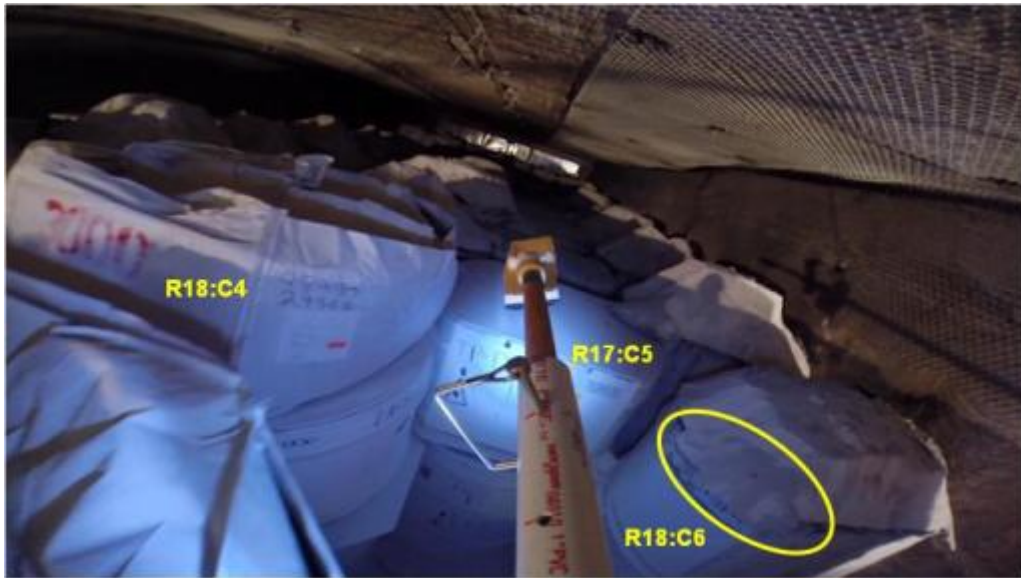
Figure 6-15: Cantilevered Bridge at R18:C6

stiffener were partially burned along with a hole through the stiffener. A stiffener on the south side bridges between the SWB and the rib. There was also evidence of flame impingement on the rib (Figure 6-17). The east (bulkhead side) stiffener fell and was not located. The SWB had vertical streaks created by melted polyethylene from the MgO super sack slip sheet flowing down the side and freezing (Figure 6-18). There was no evidence suggesting that any of the waste containers in this stack had an unfiltered release.

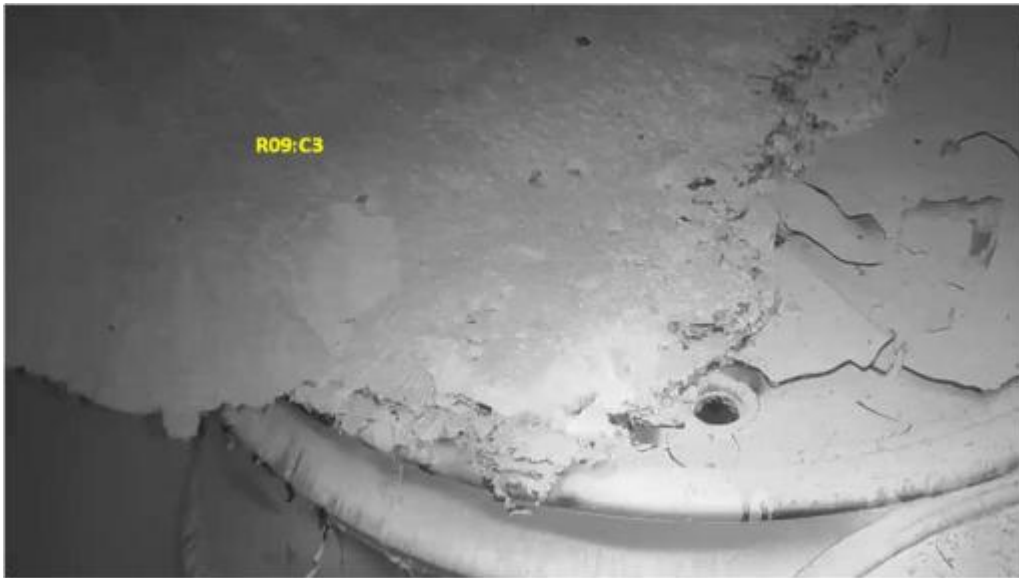
Figure 6-19: Residual Polyethylene on Dunnage Drum at R09:C3

had no observable fire damage, stretch wrap at each of the other five stacks was damaged or missing. The 55GD assembly reinforcement plates at R9:C3 and R9:C5 melted, mixed with MgO, solidified on the drum lids, and cracked into pieces (Figure 6-19, Figure 6-20, Figure 6-21, Figure 6-22, Figure 6-23 and Figure 6-24). There was no evidence of reinforcement plate remaining between the drums. In some instances melting polyethylene formed streaks on the on the side of these drums. In addition, MgO slumped onto some of the drums in both locations.

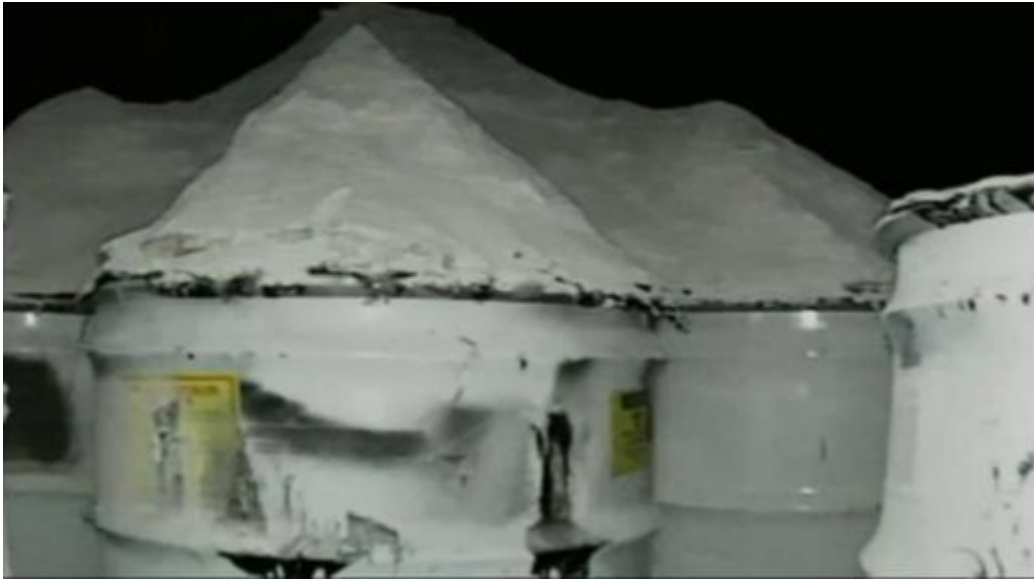
Figure 6-25: Discoloration and Residual MgO at R10:C4

While some of the TDOPs in Rows 9 and 10 exhibited streaks of melted plastic, none had substantive damage. In some instances the depth of the MgO at the floor was so deep that it obscured a substantial portion of the lower stack tier or the lower half of a TDOP.

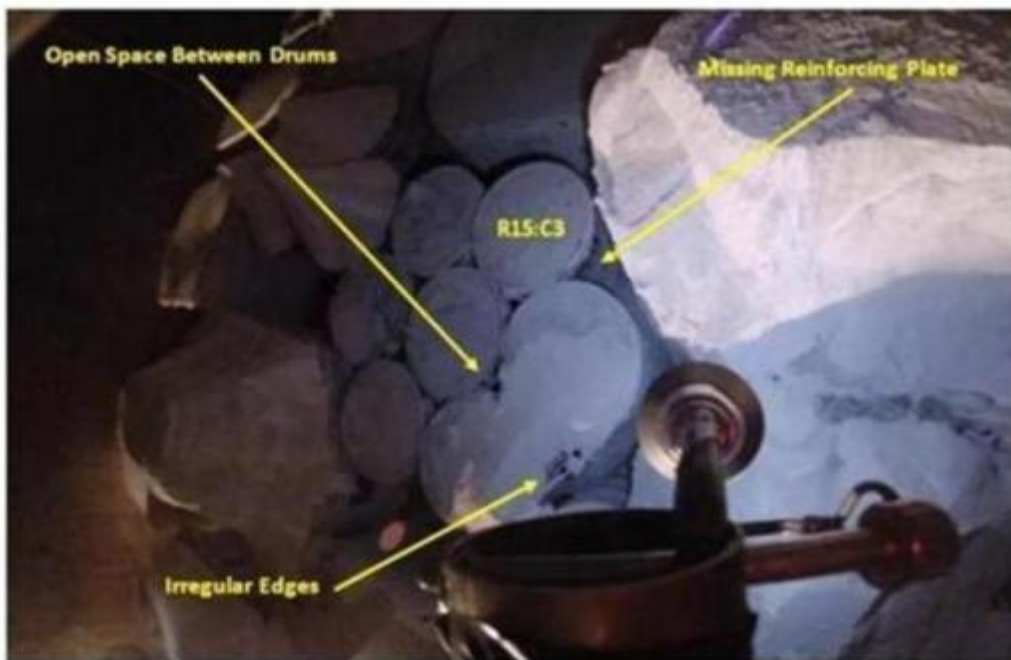
Figure 6-33: Missing Reinforcement Plate at R15:C3

The reinforcement plate at R15:C3 was damaged. The missing plate material conformed to the outline of the seven drums, including the spaces between the drums (Figure 6-33). There was residual stretch wrap visible on some portions of the assembly and some of the drum labels were undamaged (Figure 6-34). The TDOP below the 55GD assembly was undamaged.

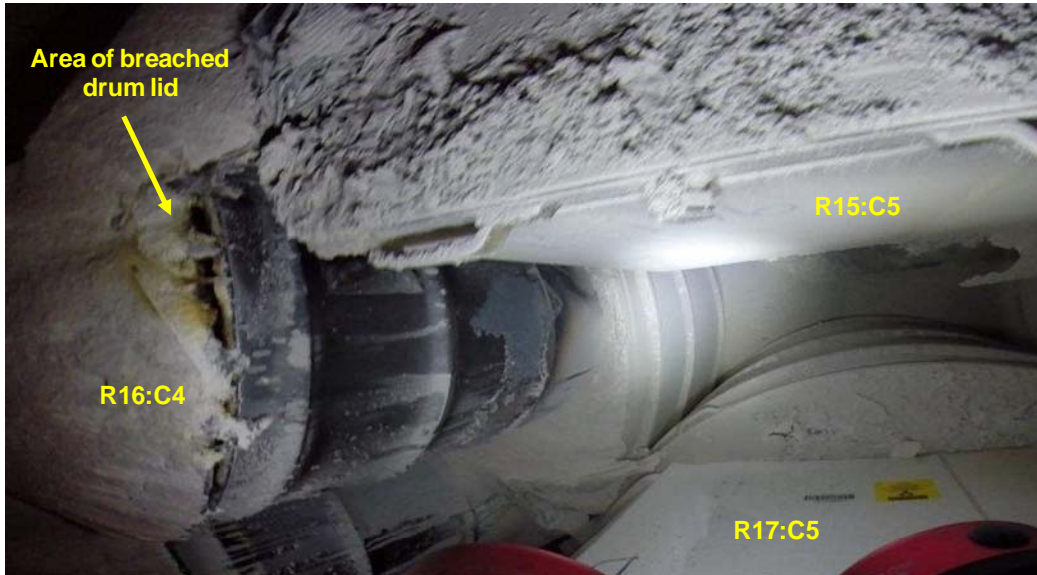
Figure 6-40: Drum 68660 at R16:C4

A drum on the top tier of R16:C4 breached (Figure 6-40). This is waste container 68660; it is on the south side of the stack. The MgO super sack fabric on the top of the 55GD assembly is substantially gone. The MgO piles on 68660 and the neighboring drum to the west are short with a low angle of repose. This was potentially caused by movement of the lid. The cones on the other drums are similar to other stacks where the MgO super sacks have been damaged.

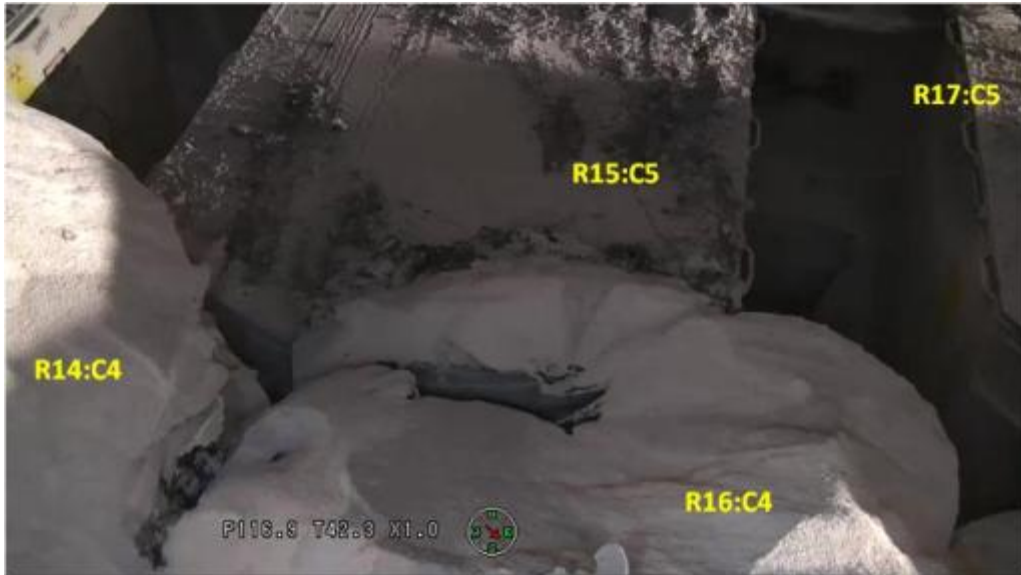
Figure 6-41: R15:C5 SWB Lid from North Looking South

There was a moderate quantity of clumped material and MgO spillover on the SWB lid at R15:C5 (Figure 6-41). The depth of this material was greatest on the northwest corner where the stack is in close proximity to R16:C4 (Figure 6-42). The north end of the lid had evidence of combusted cardboard stiffener material from the MgO bag that was placed on top of R16:C4. Additionally, there was a fallen cardboard stiffener lying on the north end of the lid. There were two spots on the southeast and southwest corners of the lid where white MgO was seen on top of the discolored material spread across the remainder of the lid. This suggests that the MgO sacks on R16:C6 and R14:C6 spilled their contents sometime after the clumped material dispersed across the lid surface.
