U.S. Department of Energy Office of Environmental Management

Accident Investigation Report

Phase 1 Radiological Release Event at the Waste Isolation Pilot Plant on February 14, 2014

April 2014

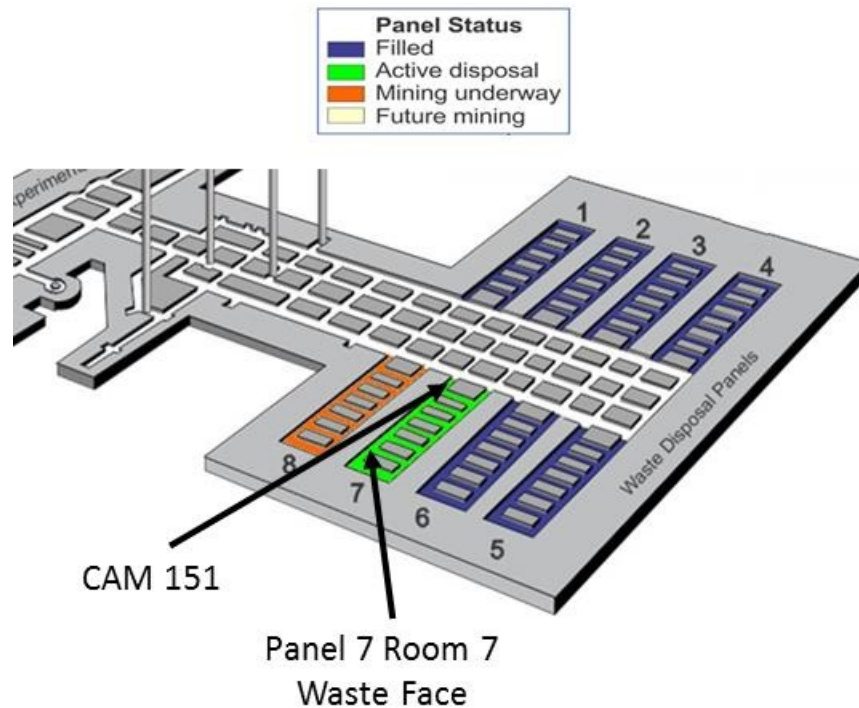
Figure 3: Location of Panel 7 and CAM-151

The WIPP U/G consists of the waste disposal area, construction area, north area, and Waste Shaft station area. The location of the suspected waste container breach at Panel 7 and CAM-151 are shown in Figure 3.

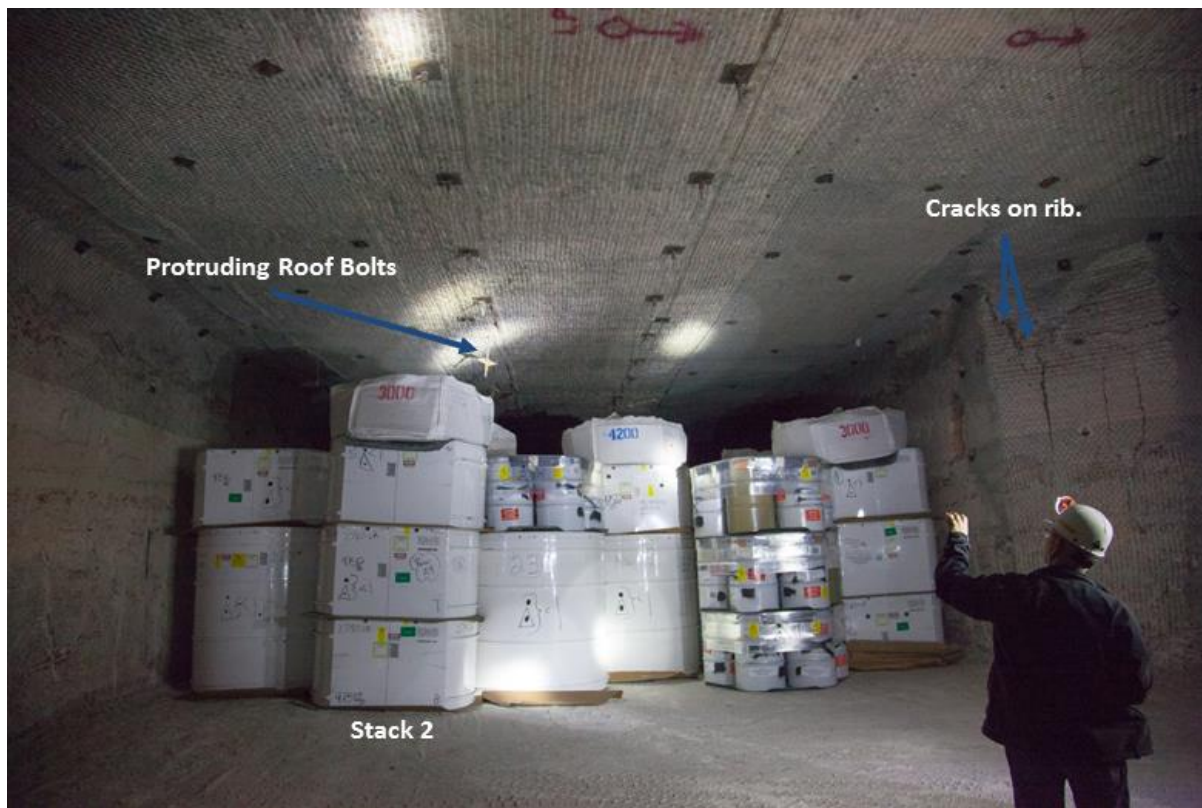
Figure 6: Active Waste Face at Panel 7 Room 7

Following a fire involving a salt haul truck on February 5, 2014, all U/G waste handling activities were suspended pending completion of a DOE Accident Investigation, implementation of critical corrective actions, and development of a recovery plan. A series of entries to the U/G were made to evaluate the fire scene and collect information in support of the Board. On February 10 and 12, two broken roof bolts were found near the mid-pillar of Panel 7 by NWP. This condition was reported to the Mine Maintenance Engineer. On February 13, members of the Board investigating the salt truck fire were in the U/G and observed these same roof bolts and reported protruding roof bolts from the back in Panel 7.

Figure 6 shows cracks in the rib behind mesh and with rock bolts, right side of photo. Figure 6 also shows an area where possible heaving of the bottom has taken place under the second stack of TRU waste on the left side of the photo. Two broken and loose roof bolts above Stack 2 on the left side.

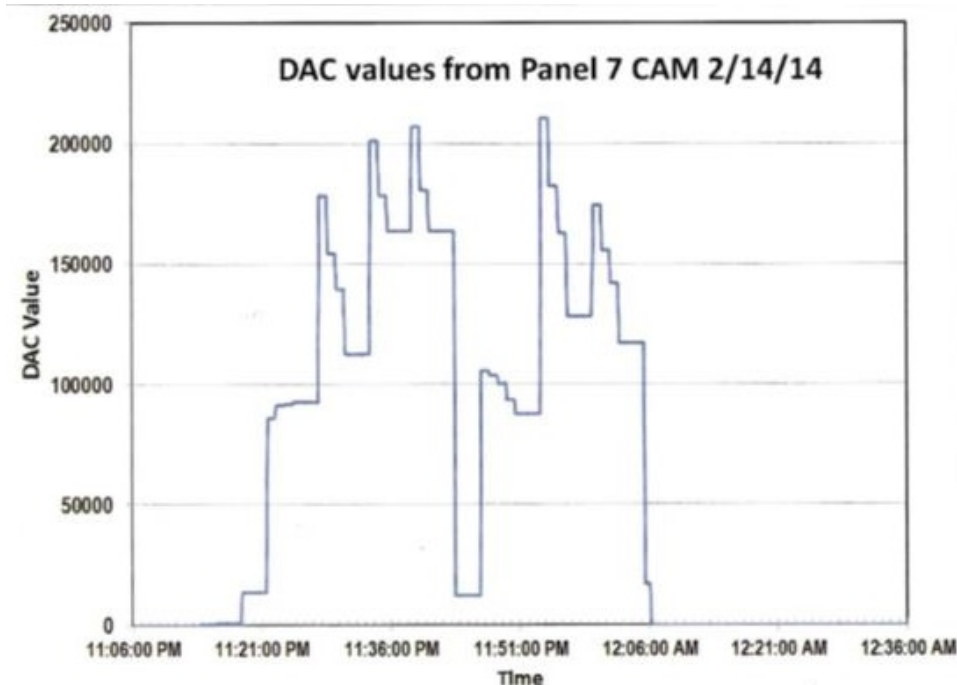
Figure 7: CAM-151 CMS

On February 14, 2014, at 2313, a “HI RAD” alarm from CAM-151 (U/G, monitoring the Panel 7 exhaust drift) was received on the CMS. The “HI RAD” setpoint for this CAM is 30 Derived Air Concentration (DAC) for alpha and beta contamination. Approximately one minute later, a “HI-HI RAD” alarm from CAM-151 was received on the CMS. The “HI-HI RAD” setpoint is 50 DAC. The CMS indicated that the CAM reading was 332 DAC. Figure 7 provides a graphical representation of CAM readings during the event.

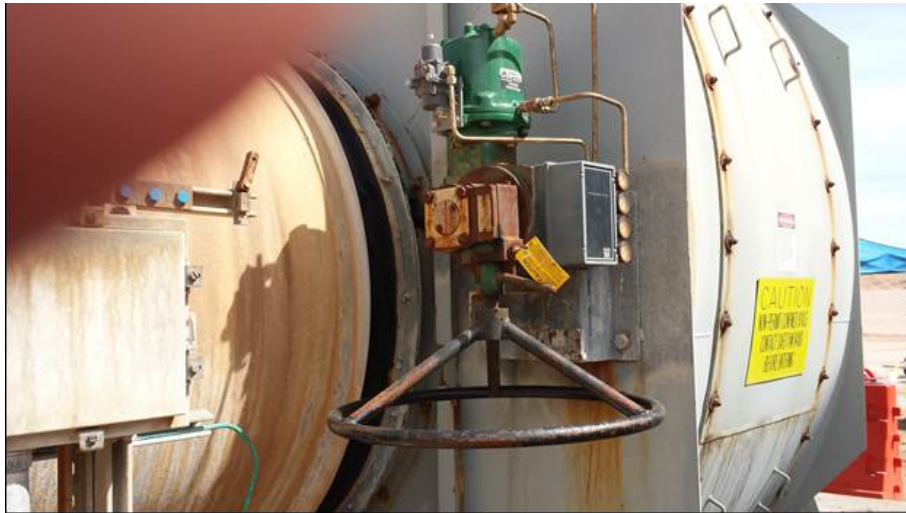
Figure 11: 860 Vortex Manual Hand Wheel

- Approximately ten years ago, the facility experienced issues associated with the actuation of the vortex dampers to the 860 fans. Automatic operation of the vortex dampers relied on input from a flow sensor. The flow sensor was failing when exposed to the harsh conditions and prevented the vortex actuator from operating properly preventing the automatic opening of the damper during fan startup. As the condition persisted, a work-around was implemented requiring an operator to be dispatched to open the damper manually at the fan inlet to allow fan startup. (Figure 11)

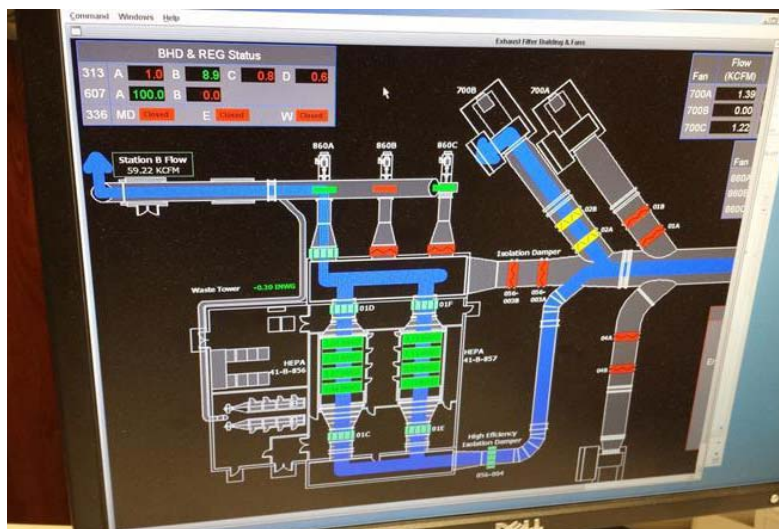
Figure 21: Central Monitoring System (CMS)

Additionally during the investigation, several sensor malfunctions were noted while observing the CMS. Examples include an airflow sensor in the underground that was indicating in excess of a 100,000 cfm flow, which should have been very low (approximately 5000 cfm). Another example includes the airflow through fan 700A, which is indicating greater than 150,000 cfm even though the fan was secured and the isolation dampers closed. Also, the CMS display indicates that the 700B fan is operating (open flow path) when the fan is secured and the dampers are closed. Additionally, the CMS has not been updated to reflect the current underground configuration with new construction of Panel 8 and adjacent bulkhead locations. (Figure 21)
