## Accident Investigation Report

## Underground Salt Haul Truck Fire at the Waste Isolation Pilot Plant February 5, 2014

March 2014

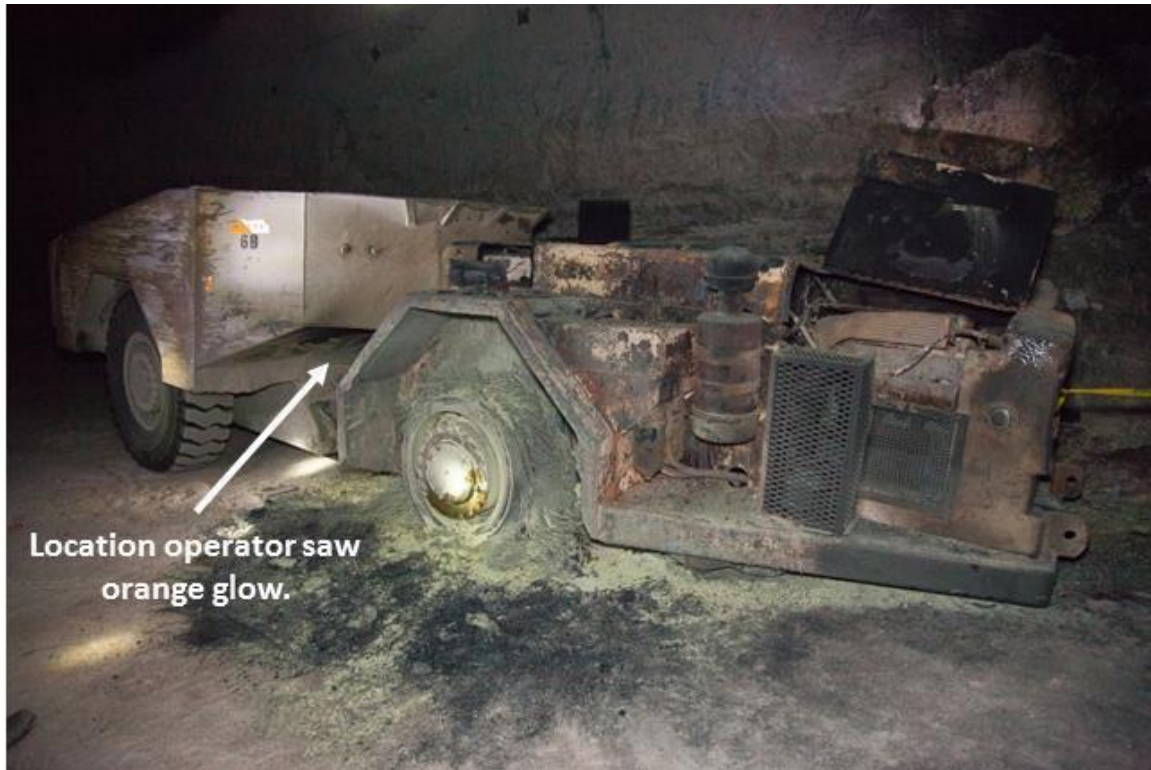
**Figure ES-1: EIMCO Haul Truck 74-U-006B after Fire**

The fire is believed to have originated in the truck's engine compartment and involved hydraulic fluid and/or diesel fuel which contacted hot surfaces on the truck, possibly the catalytic converter, and then ignited. The fire burned the engine compartment and consumed the front tires which contributed significantly to the amount of smoke and soot in the underground.

The Operator had just unloaded salt from the truck at approximately 1045 Mountain Standard Time (MST) when he noticed an orange glow and then flames between the engine and the dump sections of the truck (see Figure ES-1). The Operator attempted to extinguish the fire with a portable fire extinguisher stored on the truck and then by activating the salt haul truck's fire suppression system. Both attempts to extinguish the fire were unsuccessful. The Operator then used a mine phone to notify Maintenance of the fire, and his Supervisor overheard the conversation over a nearby mine phone, which can also be heard throughout the underground. Two nearby workers heard the discussion on the mine phone and, based on the urgency of the Operator's voice, went to the scene to see if they could assist. They began pushing a nearby 300-pound fire extinguisher to the fire when their carbon monoxide monitor alarmed and the smoke worsened. One of the workers called the Central Monitoring Room (CMR) to report the fire and smoke, and recommended evacuation of the underground.

The Board identified the direct cause of this accident to be contact between flammable fluids (either hydraulic fluid or diesel fuel) and hot surfaces (most likely the catalytic converter) on the salt haul truck, which resulted in a fire that consumed the engine compartment and two front tires.

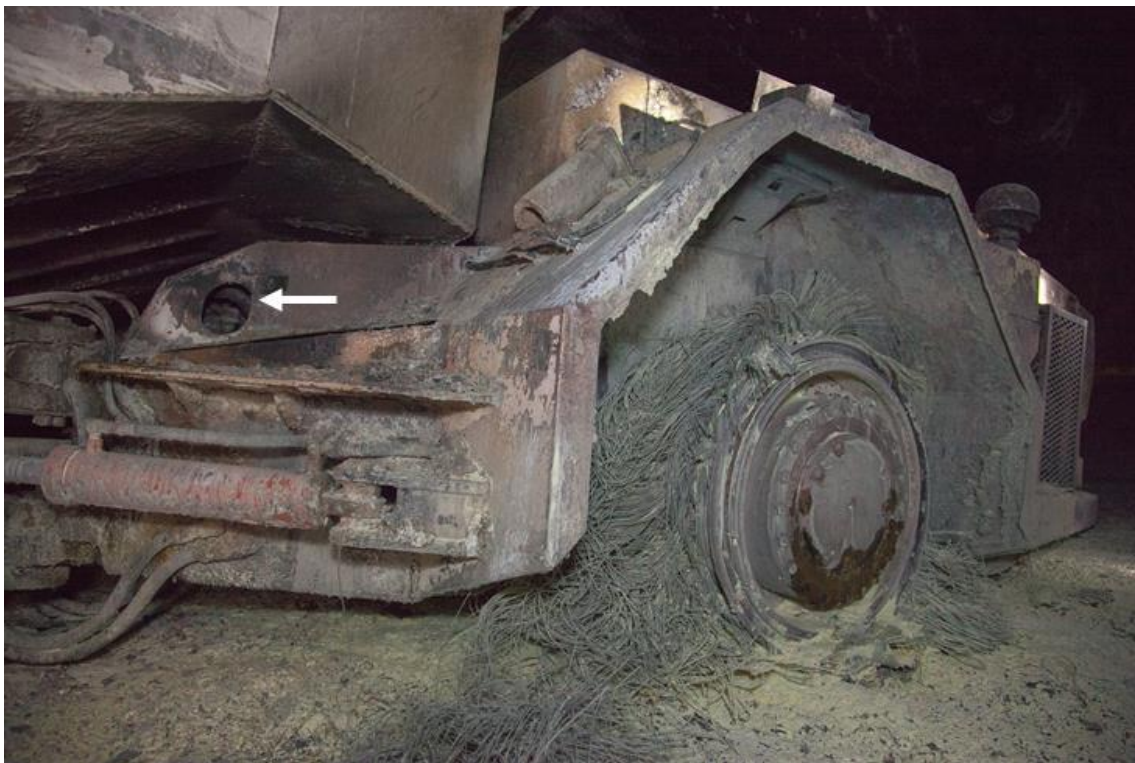
**Figure 9: Photo Showing the Area on the Salt Haul Truck where the Fire Extinguisher was Discharged**

Upon noticing the fire, the Operator stopped the truck, shut off the engine, set the brake, and exited the vehicle, taking a portable fire extinguisher which was mounted on the left front fender. The Operator proceeded to the opposite side of the vehicle, near the articulation joint and attempted to extinguish the fire by discharging the fire extinguisher into the area where the Operator had observed the fire (Figure 9).

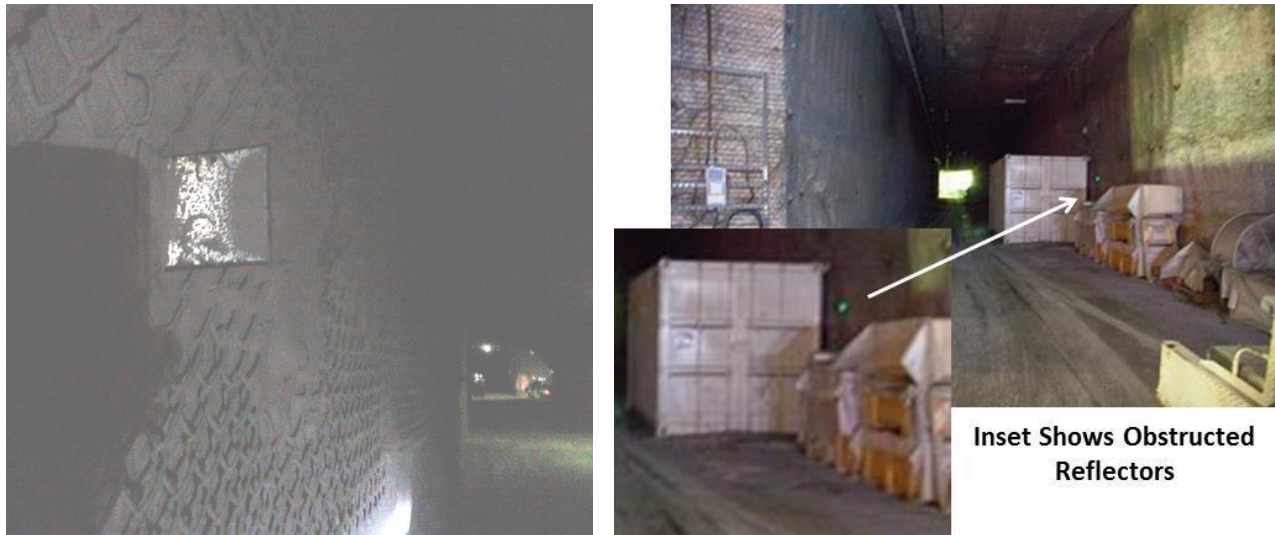
**Figure 12: Obscured Reflectors**

Large quantities of material were staged haphazardly throughout the mine. The contents of the maintenance shop lined both sides of the drift. Additionally, the U/G green and red reflectors that provide an indication of where to proceed during an evacuation were not effective. Some were obscured by being placed under the mesh fence along the ribs, while others were hidden from sight by other material stored in the mine. The Board also identified that these reflectors were covered in soot from the fire, and were located at irregular spacing (Figure 12).

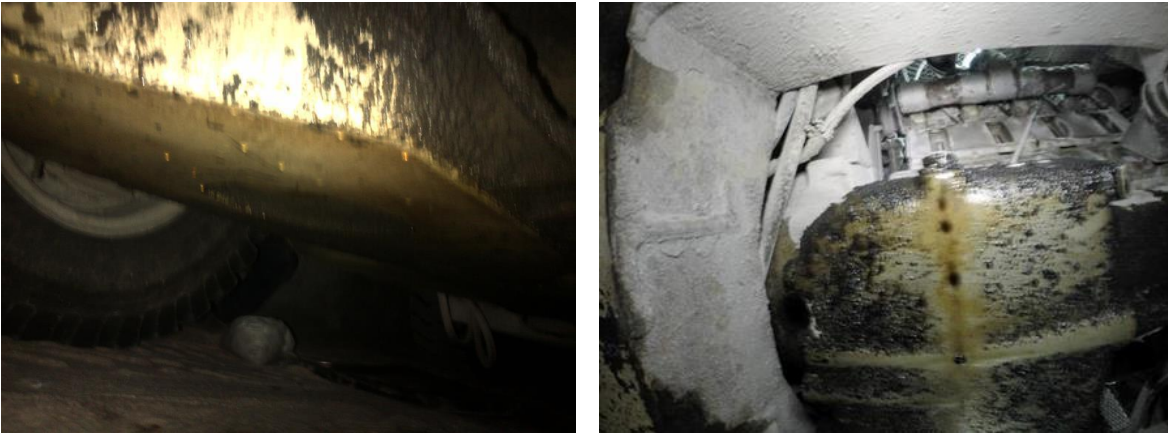
**Figure 13: Buildup of Engine Fluids on the Underside of Vehicles in the Mine**

- There was significant buildup of engine and hydraulic oil on other mining equipment including Salt Haul Truck 74U006A. (Figure 13)

**CON 6:** The NWP preventive and corrective maintenance program did not prevent or correct the buildup of combustible fluids on the salt haul truck.

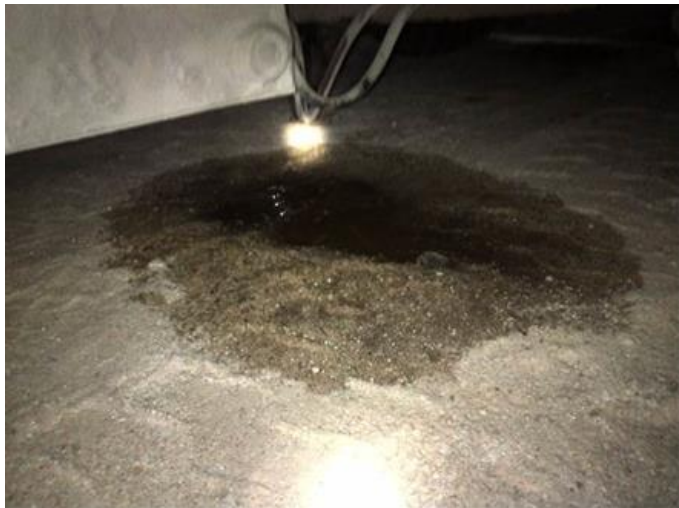
**Figure 14: Hydraulic Fluid under Truck 74U006A**

- There was a three-foot diameter puddle of hydraulic fluid underneath Salt Haul Truck 74U006A. (Figure 14)
- The daily Operator's Checklist was completed on February 5, 2014, for Salt Haul Truck 74U006A with no deficiencies indicated.
- There was an Out of Service tag on Salt Haul Truck 74U006A indicating that a lighting deficiency existed.
- Several mine phones were found to be inoperable (run to battery failure). Twelve of 40 phones tested were non-functional.
- Numerous components of the mine ventilation system were out of

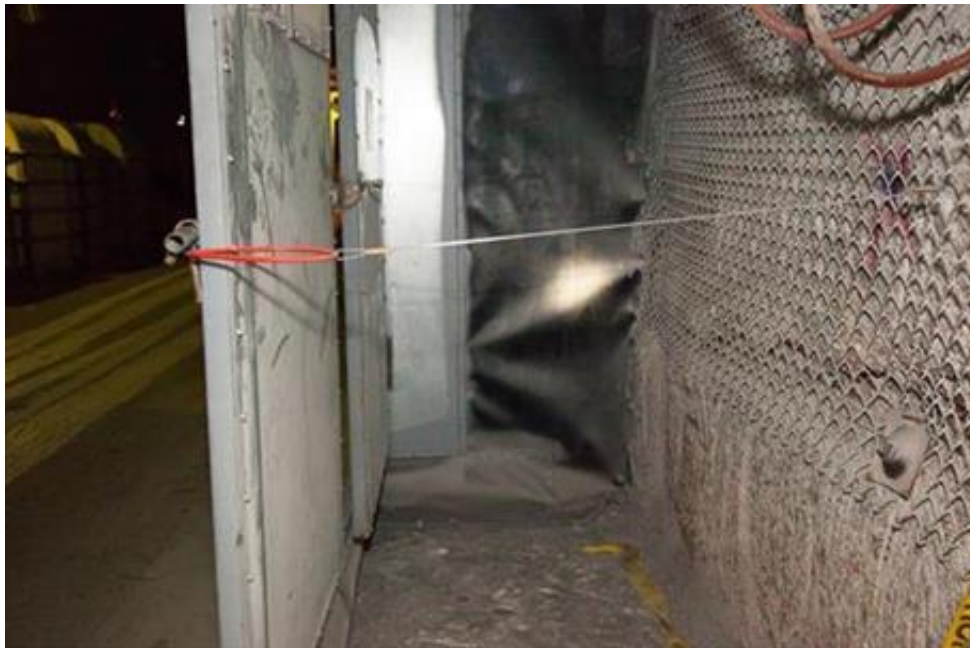
**Figure 15: One of Chained Bulkhead Doors**

- 308 bulkhead regulator cannot be remotely operated from the CMR due to the regulator being out of service or impaired. This bulkhead is located between the Waste Shaft and the exhaust shaft.

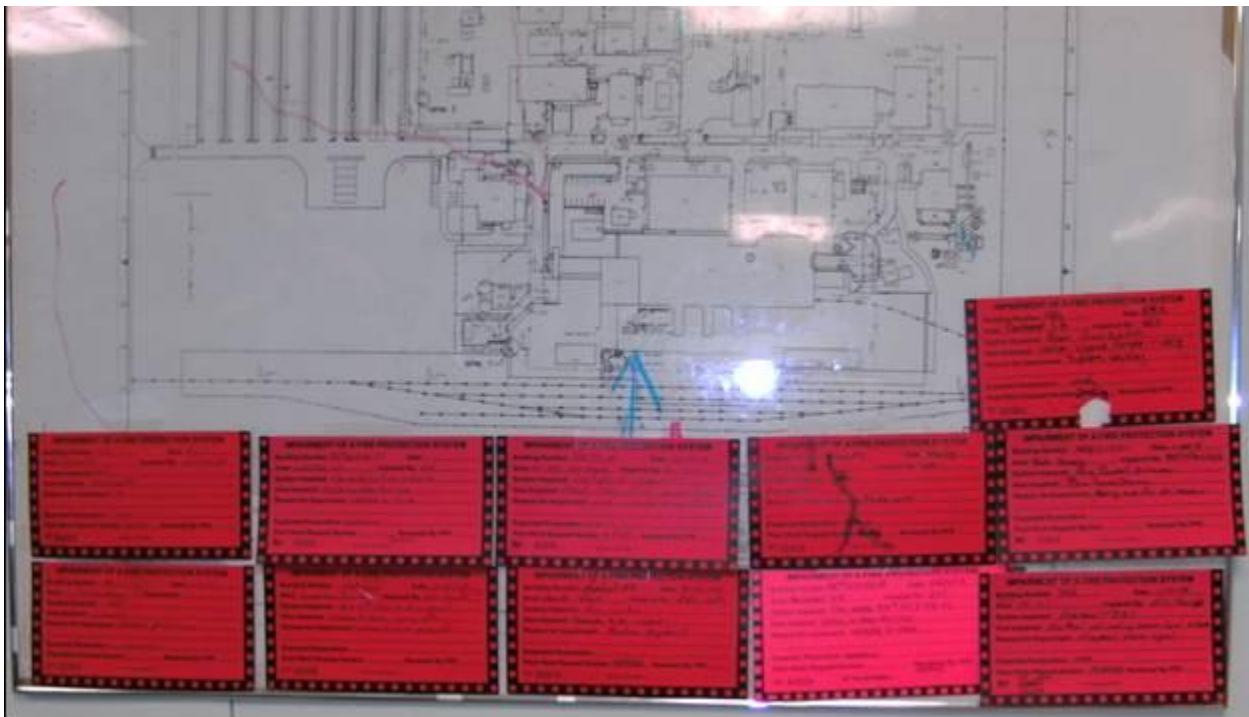
**Figure 16: Fire Protection System Impairment (Out-of-Service Tags) in the CMR**

The Board reviewed the equipment status and condition in the CMR and the U/G. The condition of critical pieces of equipment, such as the 700 exhaust fans, indicates that management has not taken prompt action to resolve longstanding deficiencies. Many items have been out of service or in a reduced status for more than six months. It was not clear that NWP had a clear approach to prioritizing maintenance activities in regard to critical equipment or that there is an effective formal process to identify compensatory measures other than a fire watch for impaired safety-related equipment. Additionally, the equipment and components that affect normal operation of the mine ventilation system did not appear to have been effectively evaluated and dispositioned regarding their impact on system operation. (Figure 16)

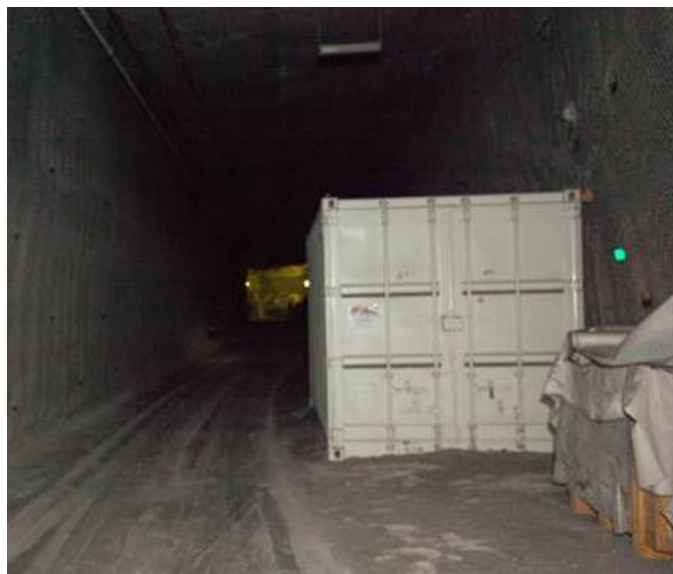
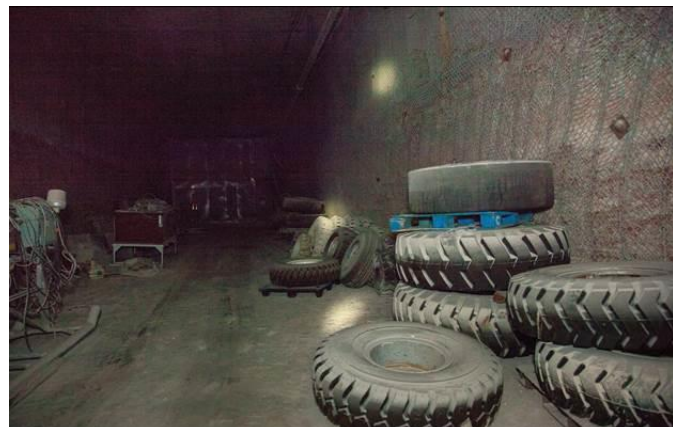
Figure 17: Combustible Loading in the Mine

While these fire protection reviews addressed only the control of combustible materials, material storage and staging is really the issue. Salt movement requires periodic touchup to the ribs and back (walls and ceiling) to maintain the non-waste work areas, and the floors throughout the mine, in good repair. As a result, equipment and materials are moved out of an area and staged in the drifts. Although this staging is temporary storage, the condition can last several months. The Board observed materials

stored on either side of the drifts, materials that obscured reflectors, and stored combustibles exceeding the 5 megawatt (MW) limit. Personnel group interviews indicated storage on only one side of drift could have made navigation in drift easier.

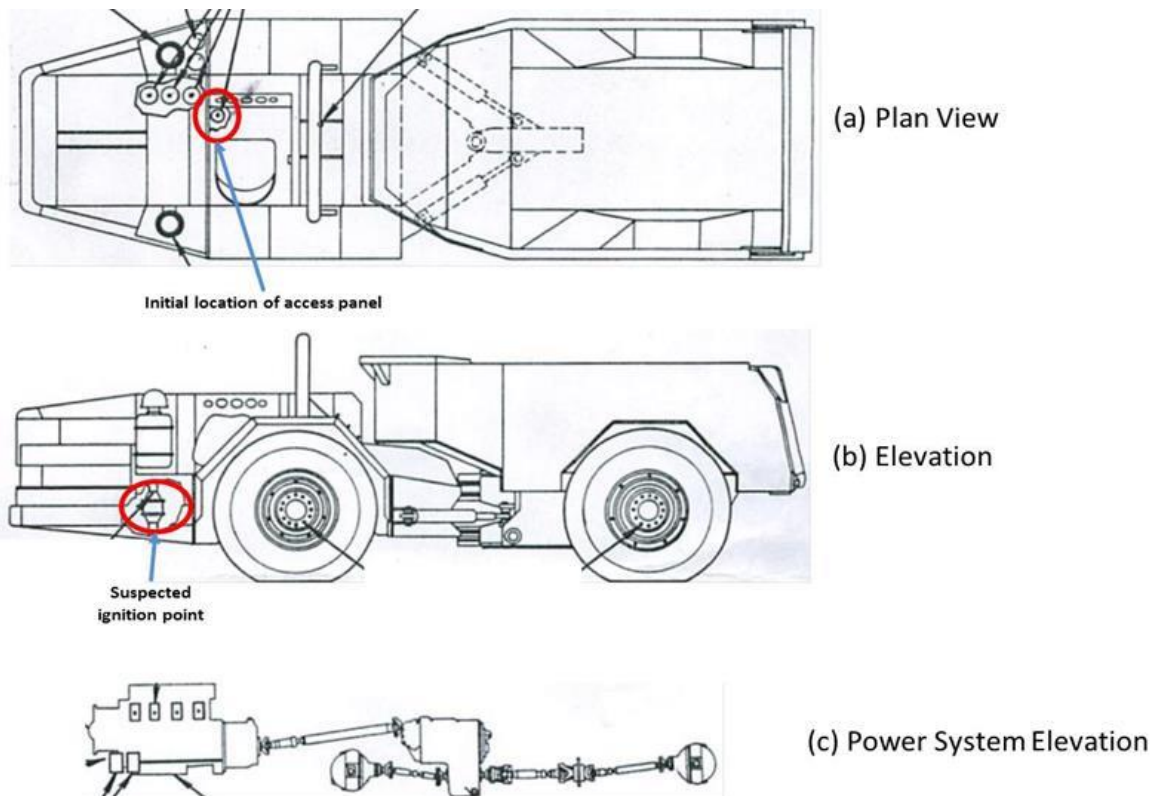
Figure 18: Salt Haul Truck

Fire ignition is presumed to have occurred near the exhaust system piping on the lower left side of the haul truck forward of the front wheel (see Figure 18). This area is enclosed by steel construction, making early visual detection difficult. The initial material ignited was a combustible liquid leaking onto the exhaust system. The liquid could have been free flowing or an accumulation on exposed surfaces. The flashpoint temperatures for haul truck fluids are listed in Table 2. The operating temperature of a typical catalytic converter will range from 300 to 500° C; however, this may exceed 500° C during abnormal engine operation (NFPA 921-2014, *Fire and Explosion Investigations*). All of these values exceed the flashpoints shown in Table 2.

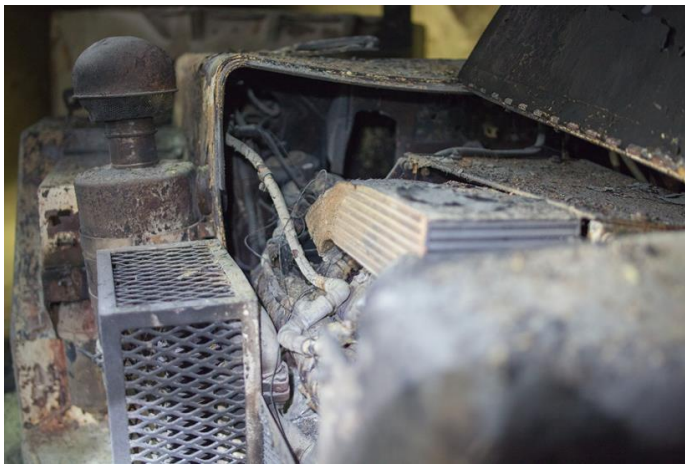
**Figure 19: Engine Cooling Coils**

The Board observed accumulated grime in the engine compartment of other salt haul vehicles that would have been sufficient to create a sustained fire that would result in additional fluid leaks. The normal hauler ventilation flow pulls air through the front grill and directs it across the cooling coils above the engine block (see Figure 19). This flow exits at the back of the engine compartment and would push the fire towards the transmission (see Figure 18, illustration (c)). In the actual fire, this condition occurred within about 5 to 10 minutes of initial ignition (assumed start time is

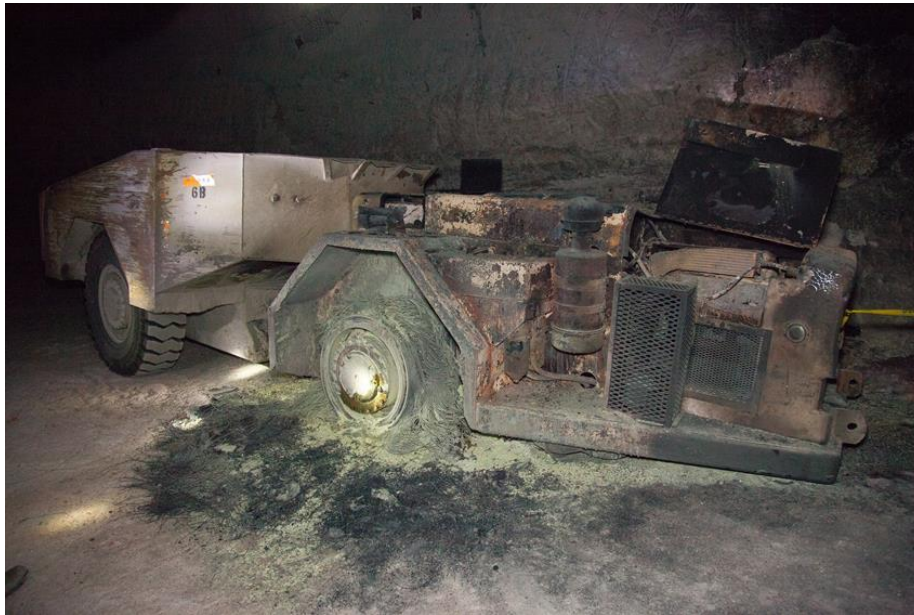
Ignition of the front tires likely occurred within 10 minutes of fire ignition (see Figure 21). Involvement of the tires produced heavy black smoke at the Salt Handling Shaft station before 1053 (1051 plus two minutes for the Salt Handling Shaft Bottom Lander to move to the station).

**Figure 21: Salt Haul Truck Damage**  
(Engine Cowling Was Opened Post-Fire)

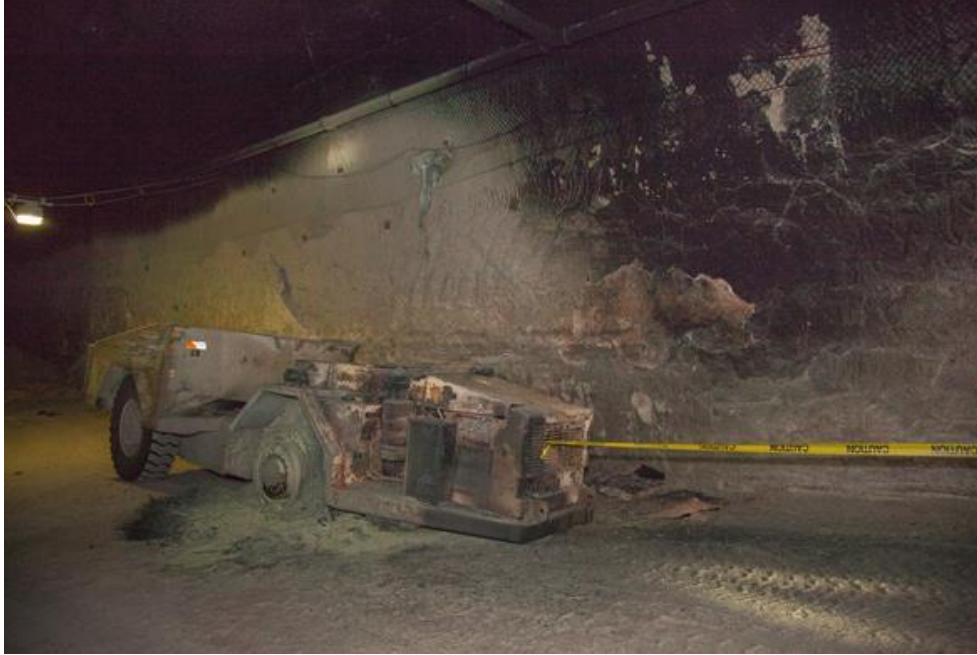
**Figure 22: Haul Truck and Rib Spalling**

The majority of the airflow entered the underground via the Air Intake Shaft, moved by the flaming salt haul truck, and moved towards the Salt Handling Shaft. This airflow, which moved from the back to the front of the truck, created a well-ventilated fire within the truck. Flames from the combustible liquid and tires impinged on the salt rib and caused spalling of the salt (see Figure 22). A smoke signature carried from this impingement point to the bulkhead doors at the base of the Salt Handling Shaft (see Figure 23). The doors created a well-mixed flow at the Salt Handling Shaft. The Exhaust Shaft flow pulled the well-mixed combustion products into the Waste and Construction Air Handling Circuits. The elevated local temperature also created an upcast flow through the Salt Handling Shaft.

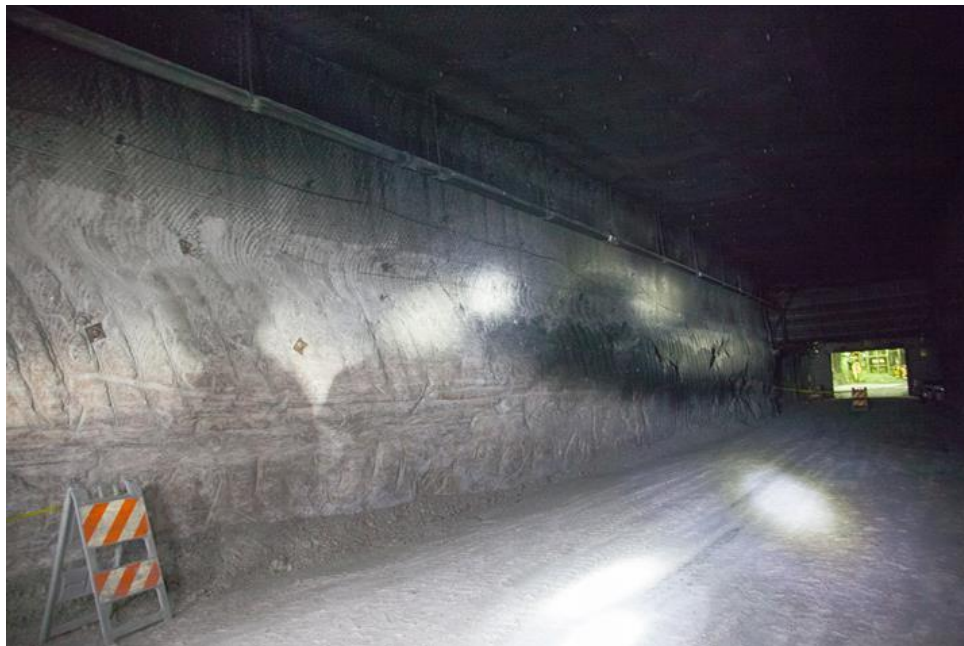
**Figure 23: Smoke Signature on Rib (Looking South)**

A portion of the airflow entering the underground traveled through the North Air Handling Circuit. The salt haul truck fire created a smoke layer in this circuit. This layer was approximately two feet deep, and traveled to the partially opened rollup door in E140. This arrangement trapped the upper smoke layer since the lower layer moved through the door.

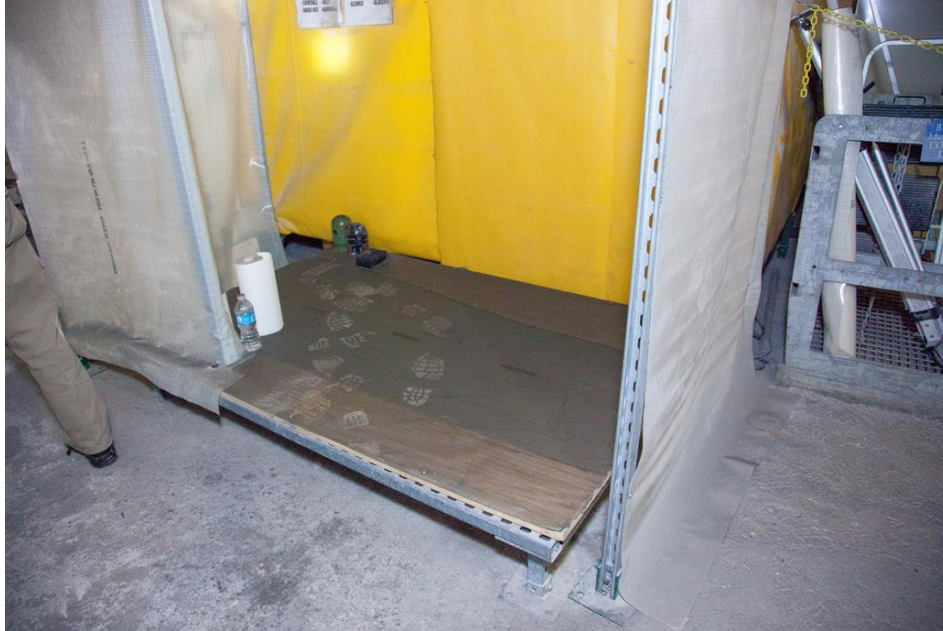
**Figure 24: Soot Deposits in North Ventilation Circuit**

At 1058, the FSM initiated a reduction of airflow; however, the fire remained well-ventilated. The change significantly decreased airflow through the North Air Handling Circuit and permitted combustion products to drop to the floor (see Figure 24). Combustion products continued to travel to the Salt Handling Shaft station to be pulled into the Waste and Construction Air Handling Circuits by the Exhaust Shaft flow, or to be upcast through the Salt Handling Shaft.

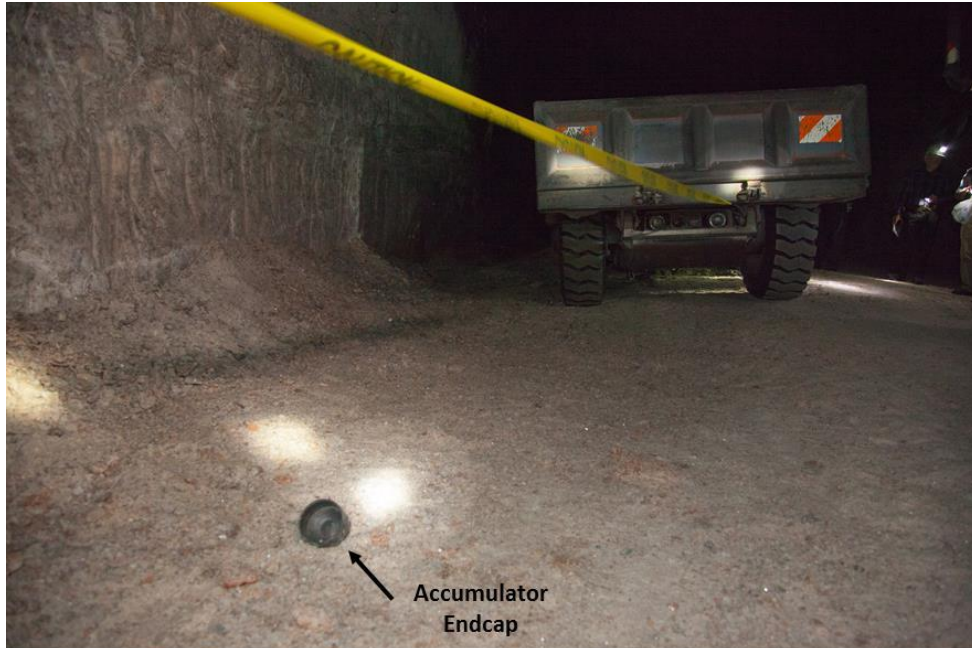
**Figure 25: Accumulator Endcap (MG 3591)**

Sometime during the intense burning period an accumulator within the engine compartment burst. This ejected an end-cap which ruptured an access plate and went through the hauler operator compartment. The end-cap traveled approximately 10 feet beyond the back of the haul truck (see Figure 25). The access plate was severely deformed and traveled approximately 20 feet beyond the end of the haul truck (see Figure 26).
