Los Alamos National Laboratory Plutonium Facility (PF-4) Seismic Safety

October 22, 2014

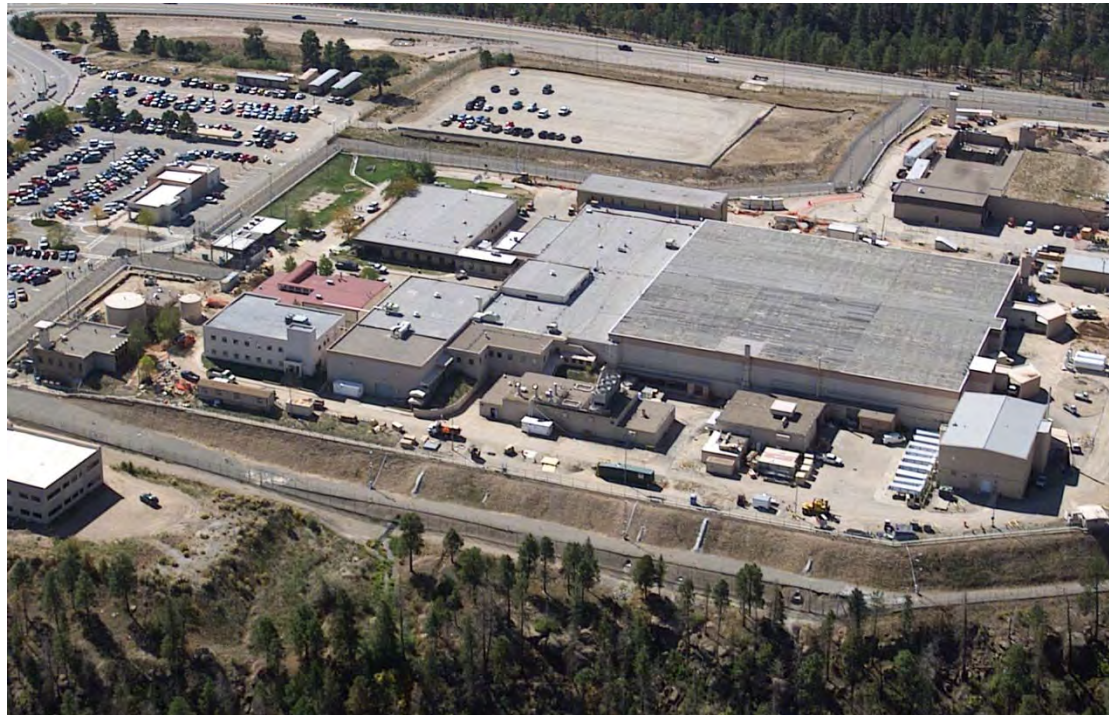
- PF-4 is the nation's enduring Pu R&D and production capability
- Designed to early 1970's requirements and a less demanding earthquake
- Operational since 1978
- Two-story shear-wall structure, partially embedded on 3 sides
- ~233,000 ft² overall

- PF-4 lacks modern ductile detailing: there is little additional margin between an earthquake that initiates failures and a slightly larger one that induces collapse
- PF-4 lacks redundant load-carrying path-ways; failure of one component (e.g., a roof girder) could lead to a progressing failures of adjacent components

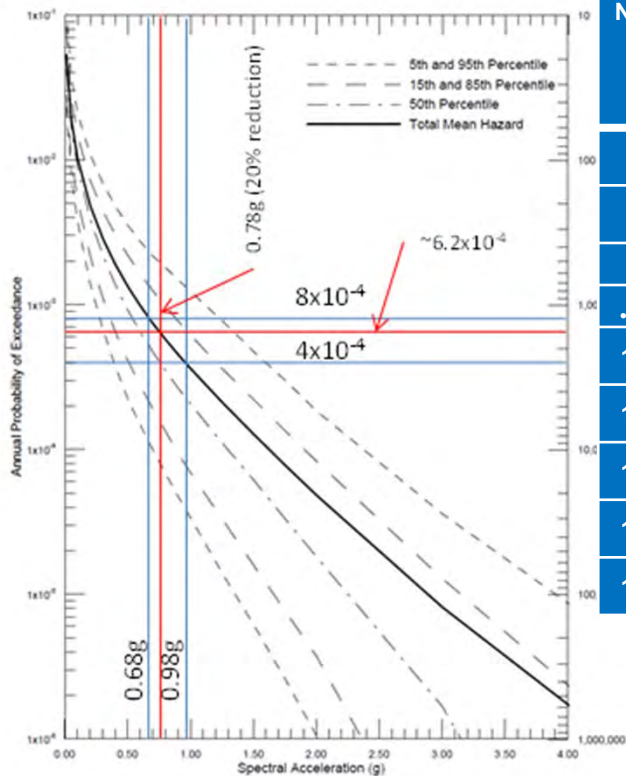
TA-55 Seismic Hazard Curve
(Spectral Accelerations @ 5Hz)

- The LANL seismic hazard curves limited the hazard-level reduction to 80%
- With this relief, as-is, PF-4 meets the alternate acceptance criteria

No.	Component Failure Mode	0.8xDBE*	Cond	1.2xDBE	Cond
			P _F ** @0.8xD BE	*	P _F ** @1.2xD BE
1	Shear failure of interior roof girder on Gridline 8 leading to collapse	0.8056	0.7%	1.2084	4.5%
2	Tension-shear failure interior roof girders leading to collapse	0.8056	0.4%	1.2084	3.0%
3	Shear failure of exterior roof girder	0.644	0.2%	0.966	1.5%
...					
10	Flexure yielding of exterior roof girder leading to large vertical displacements and possible collapse	0.644	<0.1%	0.966	0.1%
11	Tension-Flexure yielding of interior roof girder leading to large vertical displacements and possible collapse	0.8056	<0.1%	1.208	<0.1%
12	Probability of failure based on combined fragility of lateral and vertical failure modes.	0.8056	0.8%	1.2084	4.8%
13	Probability of failure based on combined fragility of vertical mechanisms	0.8056	0.8%	1.2084	4.8%
14	Probability of failure based on combined fragility of lateral mechanisms	0.6376	<0.1%	0.9564	0.7%
