Accident Investigation Report

Phase 2 Radiological Release Event at the Waste Isolation Pilot Plant, February 14, 2014

April 2015

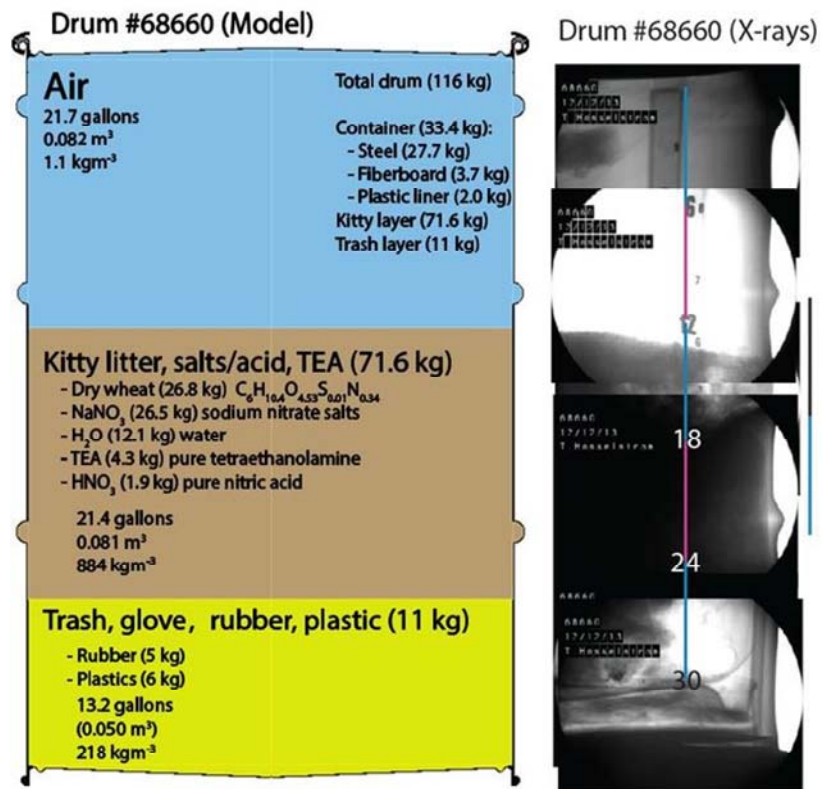
Figure 5-1: Drum 68660 Model Contents

On December 4, 2013, ES remediated parent drum S855793 in accordance with the glovebox procedure, producing daughter drums LA00000068660 (68660) and LA00000068685 (68685). Drum 68660 was repackaged by first adding some secondary waste including a tungsten-lined glovebox glove. Approximately two gallons of free liquid were decanted from the parent drum. The pH was measured and recorded to be 0 (zero). The pH was adjusted using KOLORSAFE® to an unspecified final pH. Swheat Scoop® organic kitty litter was added as the absorbent and was placed in the drum. Additional bags of nitrate salt were absorbed and placed in the drum. See Figure 5-1 for a drum contents model.

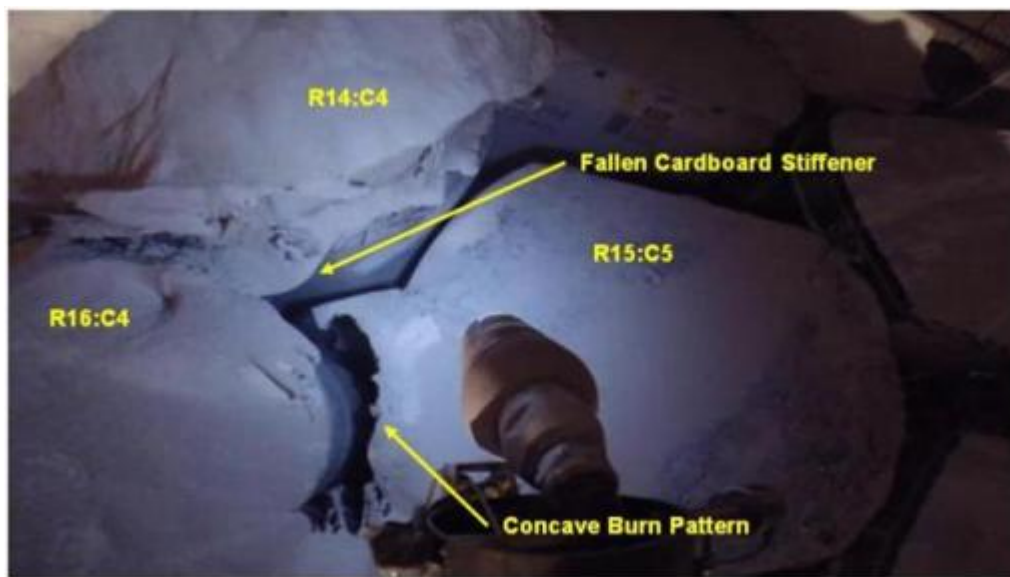
Figure 6-6: Evidence of Flaming Combustion Irregular Edge Surfaces at R15:C5

The cardboard stiffeners collapsed into multiple final orientations: hanging from a stack edge, cantilevered over the edge of a waste package, bridging between two stacks, or resting on the floor. Some of the locations where the stiffeners were cantilevered or bridging exhibited irregular edge surfaces (Figure 6-5). At R15:C5 there was a concave burn pattern in the portion of the cardboard that was cantilevered over the edge of the lid of a standard waste box (SWB) (Figure 6-6). The burn-pattern is typical of horizontal material exposed to a flame from below. Similar materials may burn as long as exposed to an external flame, but will likely self-extinguish once the flame is removed. There were also smaller cardboard remnants lying on the lid. These remnants display striations of the corrugated layer within the original cardboard matrix.

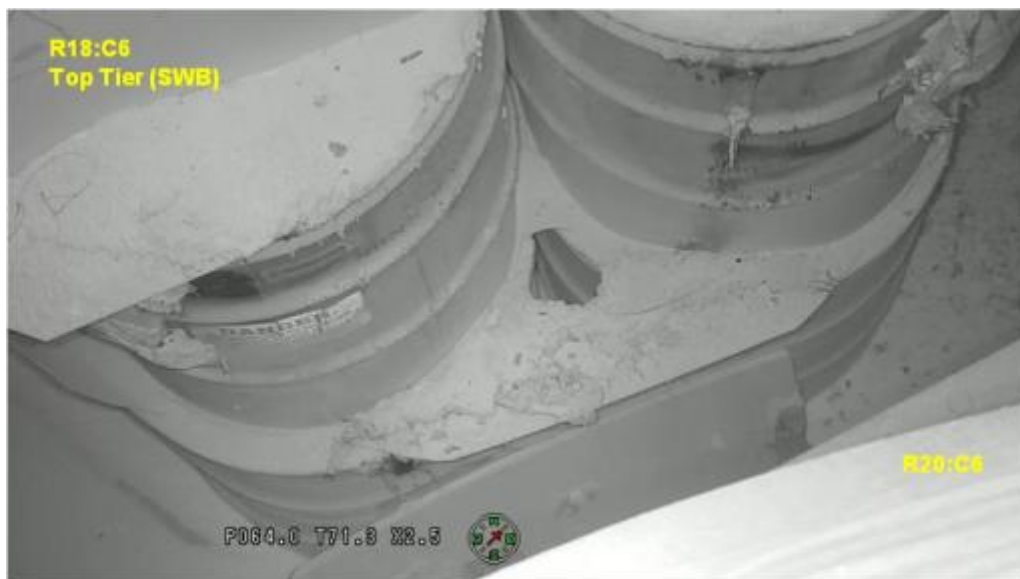
Figure 6-12: Face Side (west) of R18:C6 Middle Tier

Based on the orientation of the stack, the stack damage, and the ventilation direction, a hot or flaming ember is considered a plausible means of fire propagation to R18:C6. This ember landed on the fiberboard slip sheet that was below this SWB and caused ignition of the fiberboard. The fire consumed the exposed fiberboard above the two west drums (the drums on the face-side of the array, Figure 6-11). The reinforcement plate below the fiberboard burned and melted with the remaining material following the contour of the two west drums (Figure 6-12). The middle-tier stretch wrap on the west side was also damaged. There are streaks of polyethylene on the sides of the waste drums. The slip sheet and reinforcement plate between

This fire-propagation mechanism likely occurred at R18:C6, where the exposed MgO super sack fabric or a slip sheet ignited when the ventilation perturbation occurred following the failure of waste drum 68660 (Figure 6-12).

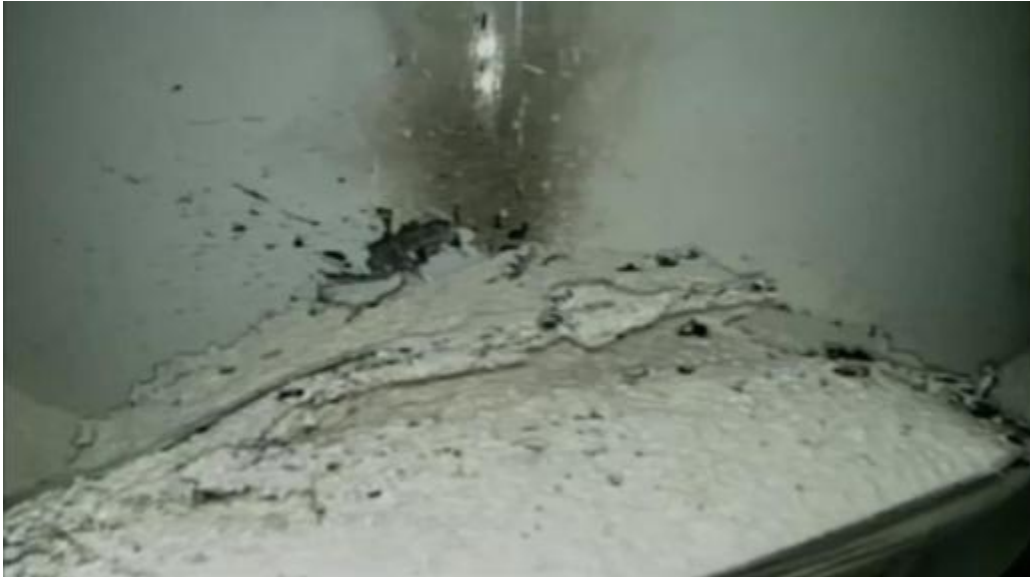
Figure 6-13: Face View (west) Base of Middle Tier Drum at R18:C6

the middle and bottom 55GD assemblies appears to be intact although a variety of debris have accumulated on the top of the reinforcement plate. In some locations fallen material has combusted resulting in discoloration of a waste container. In one location sufficient flame exposure occurred to leave a clean burn pattern where all of the dirt, paint, and soot has burned away leaving a bright metal surface (Figure 6-13). The stretch wrap on the north-west corner of the lower tier was also damaged by flames (Figure 6-14). Except as noted, no other damage to the stretch wrap was identified in this stack.

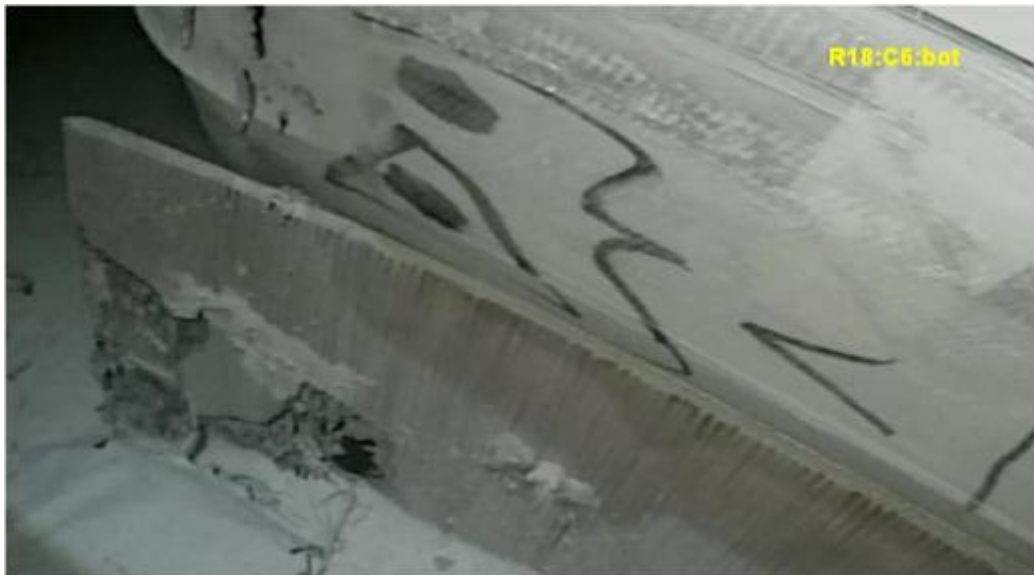
Figure 6-16: Face View (west) – Debris at Base of R18:C6

The MgO super sack was damaged by the fire. The polypropylene fabric melted, burned or fell from all sides of the super sack. On the north side the cardboard stiffeners and fabric were trapped between the MgO and the SWB lid. The stiffener and fabric formed a cantilevered bridge that supported a pile of displaced MgO (Figure 6-15). On the west side, a stiffener fell to the floor where it was partially covered by MgO (Figure 6-16). The vertical edges of this

stiffener were partially burned along with a hole through the stiffener. A stiffener on the south side bridges between the SWB and the rib. There was also evidence of flame impingement on the rib (Figure 6-17). The east (bulkhead side) stiffener fell and was not located. The SWB had vertical streaks created by melted polyethylene from the MgO super sack slip sheet flowing down the side and freezing (Figure 6-18). There was no evidence suggesting that any of the waste containers in this stack had an unfiltered release.

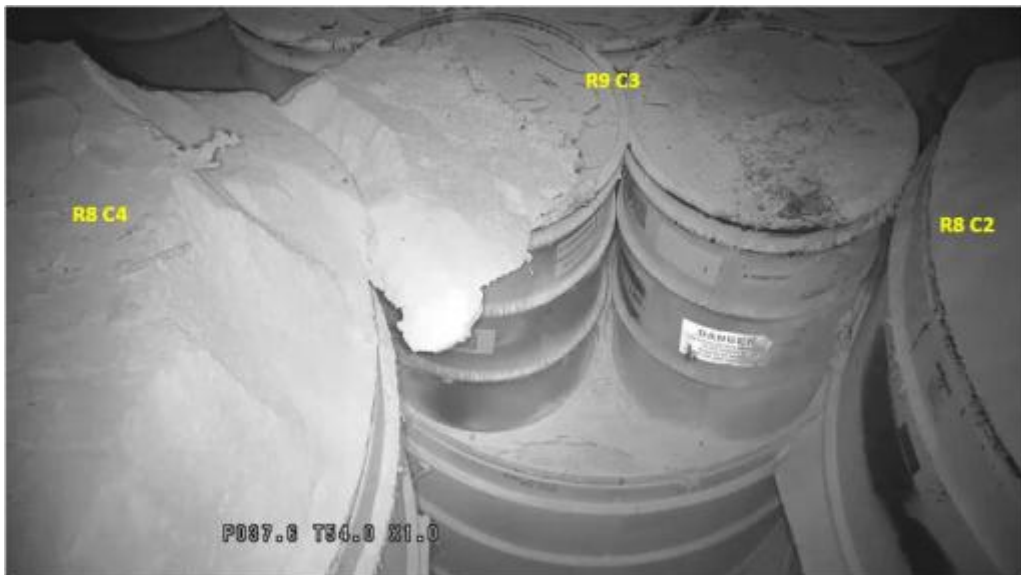
Figure 6-20: R9:C3 Bulkhead View (east)

had no observable fire damage, stretch wrap at each of the other five stacks was damaged or missing. The 55GD assembly reinforcement plates at R9:C3 and R9:C5 melted, mixed with MgO, solidified on the drum lids, and cracked into pieces (Figure 6-19, Figure 6-20, Figure 6-21, Figure 6-22, Figure 6-23 and Figure 6-24). There was no evidence of reinforcement plate remaining between the drums. In some instances melting polyethylene formed streaks on the on the side of these drums. In addition, MgO slumped onto some of the drums in both locations.

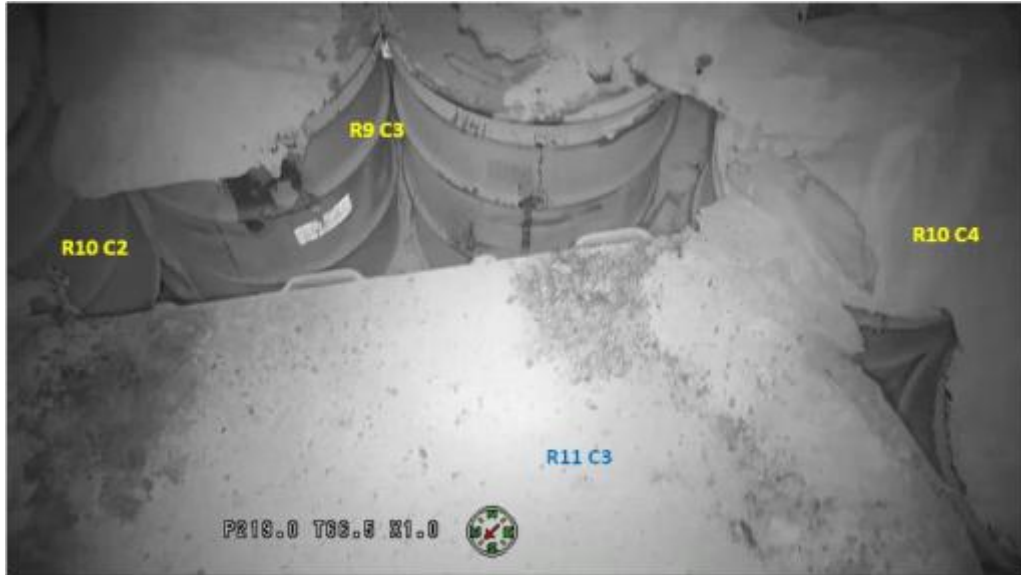
Figure 6-21: R9:C3 West Side

The MgO super sacks in Row 10 were damaged, with most of the fabric melted or gone (Figure 6-21, Figure 6-22, Figure 6-24, Figure 6-25, and Figure 6-26). The residual MgO formed conical piles consistent with the outline of the waste containers on the top tier at each stack. At R10:C6 the 100GD assembly slip sheet, the middle tier reinforcement plate and slip sheet, were partially damaged and conformed to the outline of the drums (Figure 6-27). Many locations had

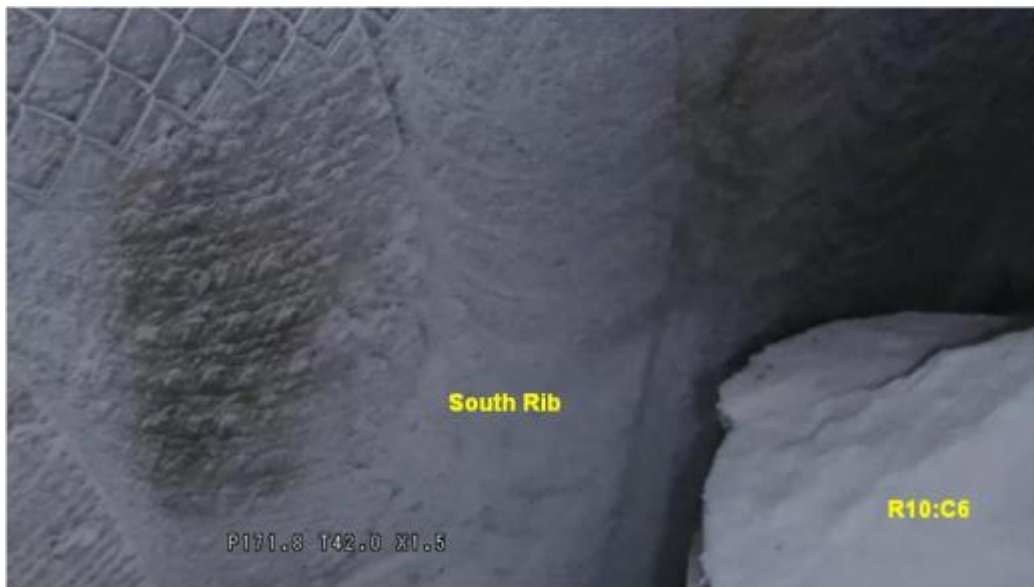
Figure 6-28: Flame Impingement Evidence on South Rib near Row 10

evidences of black discolorations on the sides of the waste drums. There was also evidence of flame impingement on the south rib (Figure 6-28).

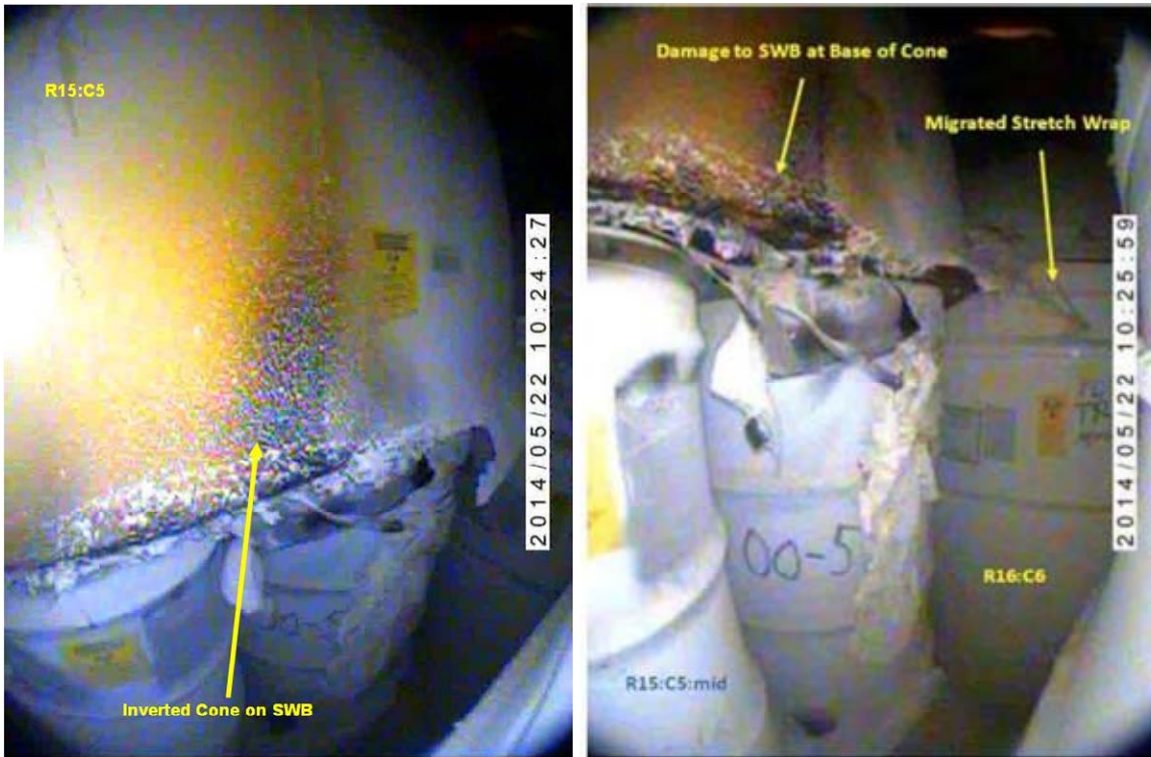
Figure 6-36: Side of SWB at R15:C5:top

The reinforcement plate and fiberboard slip sheet between the middle and top tiers of R15:C5 was severely damaged and partly burned on the west (face) and north sides. Much of the polyethylene stretch wrap was missing from these locations. There was discoloration indicative of overheating on the west side of the SWB near the seal (Figure 6-35). There was an inverted-cone pattern on the SWB centered between the two west-most middle-tier drums (Figure 6-36). The fiberboard slip sheet had a U-shaped damage pattern (Figure 6-37). This is indicative of flame exposure to the fiberboard from below. When the flame exposure ceased, combustion of the horizontal fiberboard likely stopped. The fiberboard slip sheet and reinforcement plate were badly damaged below the north end of the SWB (Figure 6-38). Char from the slip sheet conformed to the middle tier 55GDs.

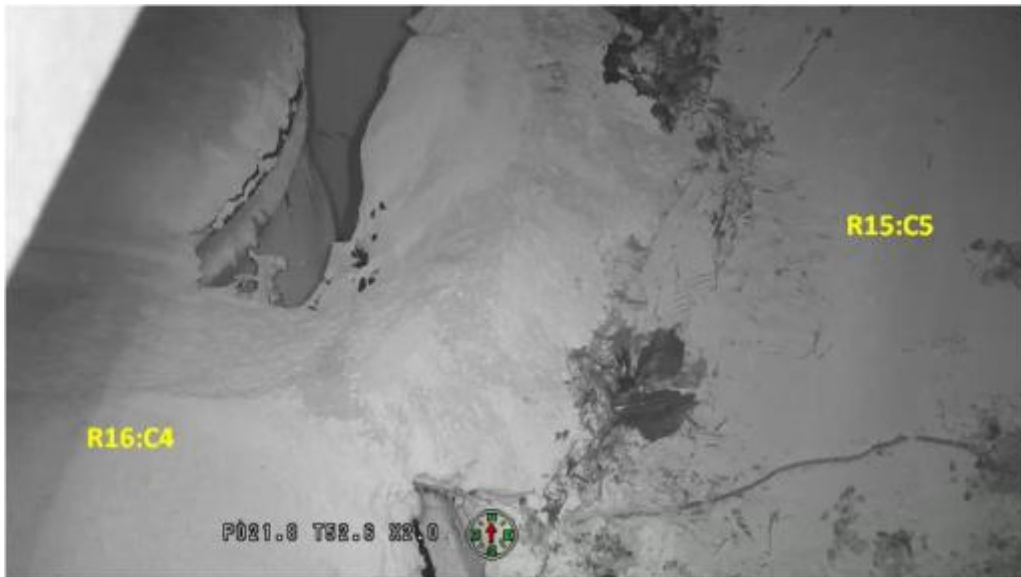
Figure 6-42: Bridge between the R15:C5 SWB Lid and R16:C4

There was a moderate quantity of clumped material and MgO spillover on the SWB lid at R15:C5 (Figure 6-41). The depth of this material was greatest on the northwest corner where the stack is in close proximity to R16:C4 (Figure 6-42). The north end of the lid had evidence of combusted cardboard stiffener material from the MgO bag that was placed on top of R16:C4. Additionally, there was a fallen cardboard stiffener lying on the north end of the lid. There were two spots on the southeast and southwest corners of the lid where white MgO was seen on top of the discolored material spread across the remainder of the lid. This suggests that the MgO sacks on R16:C6 and R14:C6 spilled their contents sometime after the clumped material dispersed across the lid surface.

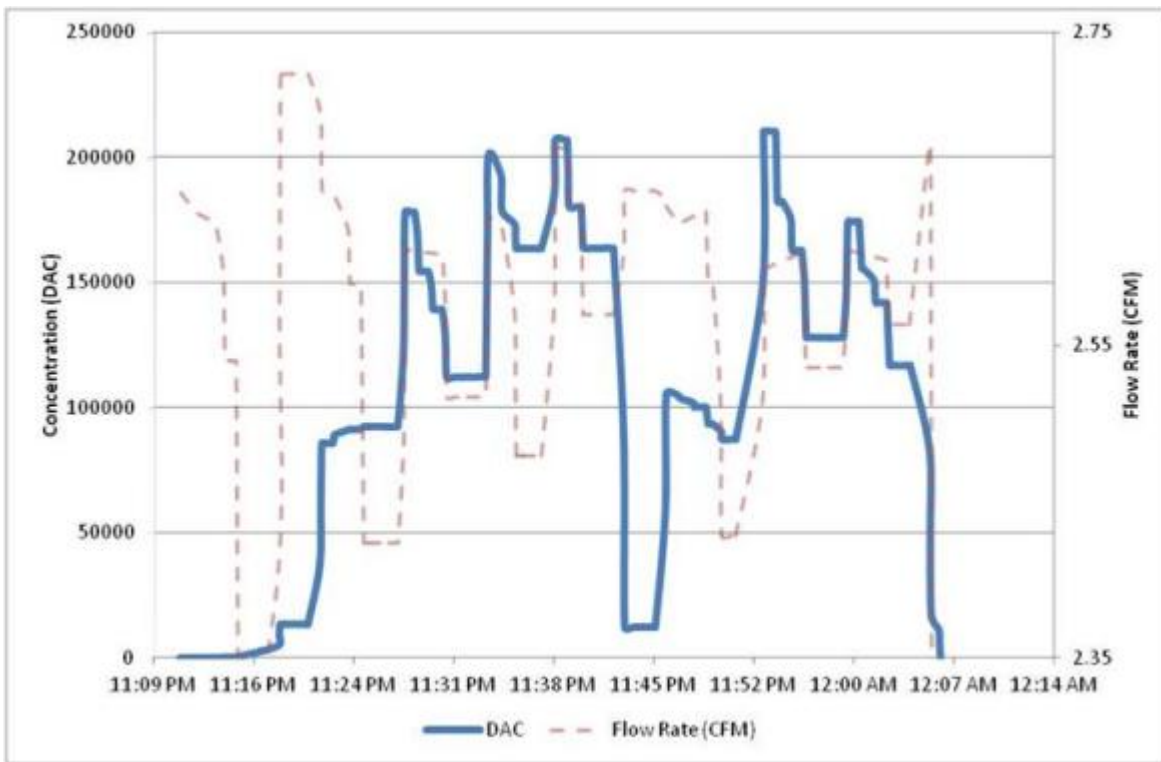
Figure 6-50: Real-Time Air Concentrations Measured By CAM 151 with the CAM Flow Rate

The total activity on each filter, expressed as DAC-hours, is related to the average air concentration over the entire period the filter was in use, and does not provide information about the fluctuation of real-time airborne concentrations during the time each filter is in use. As indicated in CAM log messages, the filter was rapidly clogging during the event, and required frequent filter changes at irregular intervals. However, as a filter is in use, the CAM is measuring the radioactivity on the filter at approximately 4-second intervals, and reporting the corresponding real-time concentration, which is then relayed to the CMS. The real-time DAC results are limited in their accuracy for quantitative results as the event progressed to later stages due to filter loading with ash/soot and potential alpha particle burial loss introducing measurement uncertainties; however the data are still appropriate for evaluating changes, trends, patterns, and timelines of the progression of airborne radioactivity concentrations. These real-time air concentrations as measured by CAM 151, along with the CAM flow rate, are presented in Figure 6-50.

CAM airborne radioactivity data correlates with the timeline for the event initiation, progression, and termination. The data indicated rapid increases/decreases in airborne radioactivity concentration over the duration. Three CAM filters (2, 7, and 11) were selected for extended gamma assays and chemical analyses. Extended gamma assays on those three CAM filters measured an actinide signature similar to what was found on the FAS. Table 6-6 is summary of the results of the three selected CAM filters.

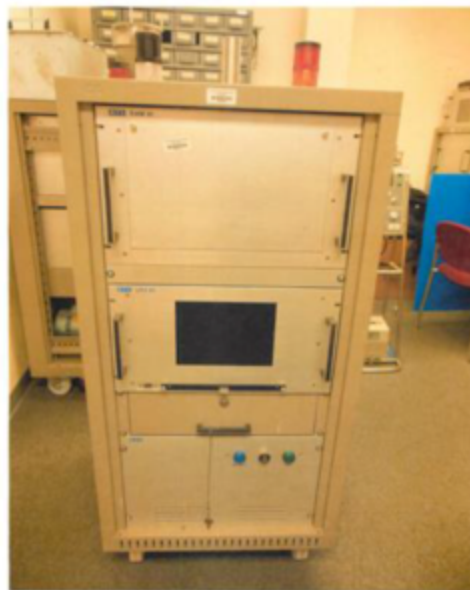
On Friday, February 14, 2014, at approximately 2314, a "HI HI" radiation alarm was received in the Central Monitoring Room (CMR) at the DOE WIPP facility approximately 27 miles east of Carlsbad, New Mexico. The alarm was triggered from a CAM (Figure ES-1) in the U/G which was monitoring airborne radioactivity levels in air exhausting from Panel 7, an active waste panel where TRU waste was being emplaced for disposal.

Figure ES-1: RADOS Continuous Air Monitor

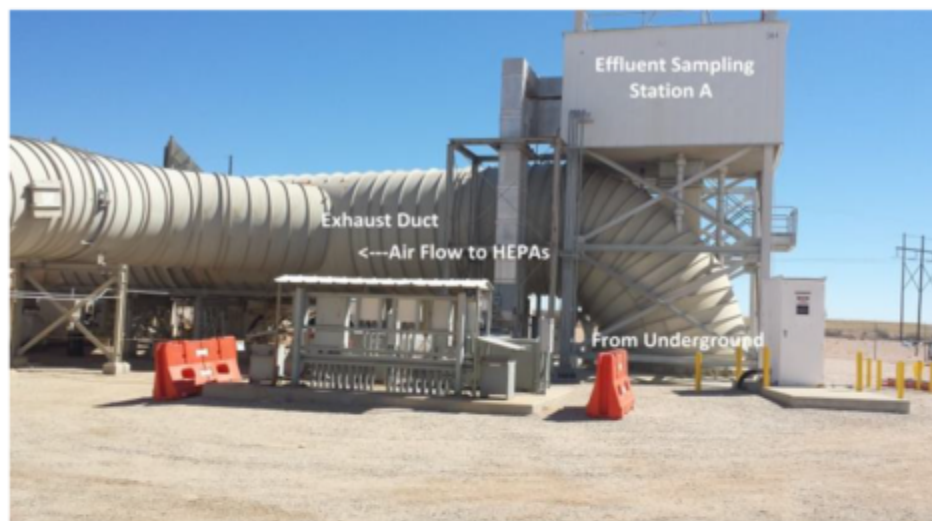
On Saturday, February 15, 2014, the filters were counted at 0715; the RCM reported 4.4 million disintegrations per minute (dpm) alpha contamination on the filters from the effluent sample station upstream from the HEPA filters (Station A) (Figure ES-2). Preliminary data indicated the presence of TRU materials.

Figure ES-2: Exhaust Air Shaft and Effluent Sample Station A
