U.S. Department of Energy Office of Environmental Management

Accident Investigation Report

Phase 1 Radiological Release Event at the Waste Isolation Pilot Plant on February 14, 2014

April 2014

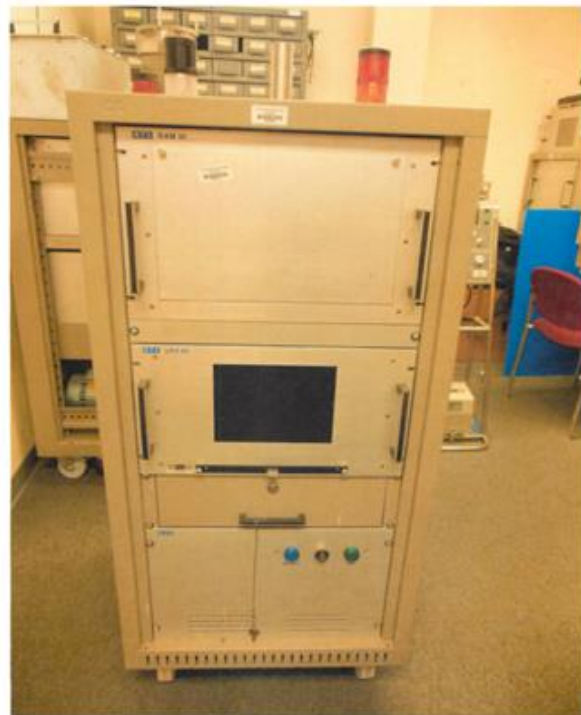
Figure ES-1: RADOS Continuous Air Monitor

On Friday, February 14, 2014, at approximately 2314, a "HI HI" radiation alarm was received in the Central Monitoring Room (CMR) at the DOE WIPP facility approximately 27 miles east of Carlsbad, New Mexico. The alarm was triggered from a CAM (Figure ES-1) in the U/G which was monitoring airborne radioactivity levels in air exhausting from Panel 7, an active waste panel where TRU waste was being emplaced for disposal.

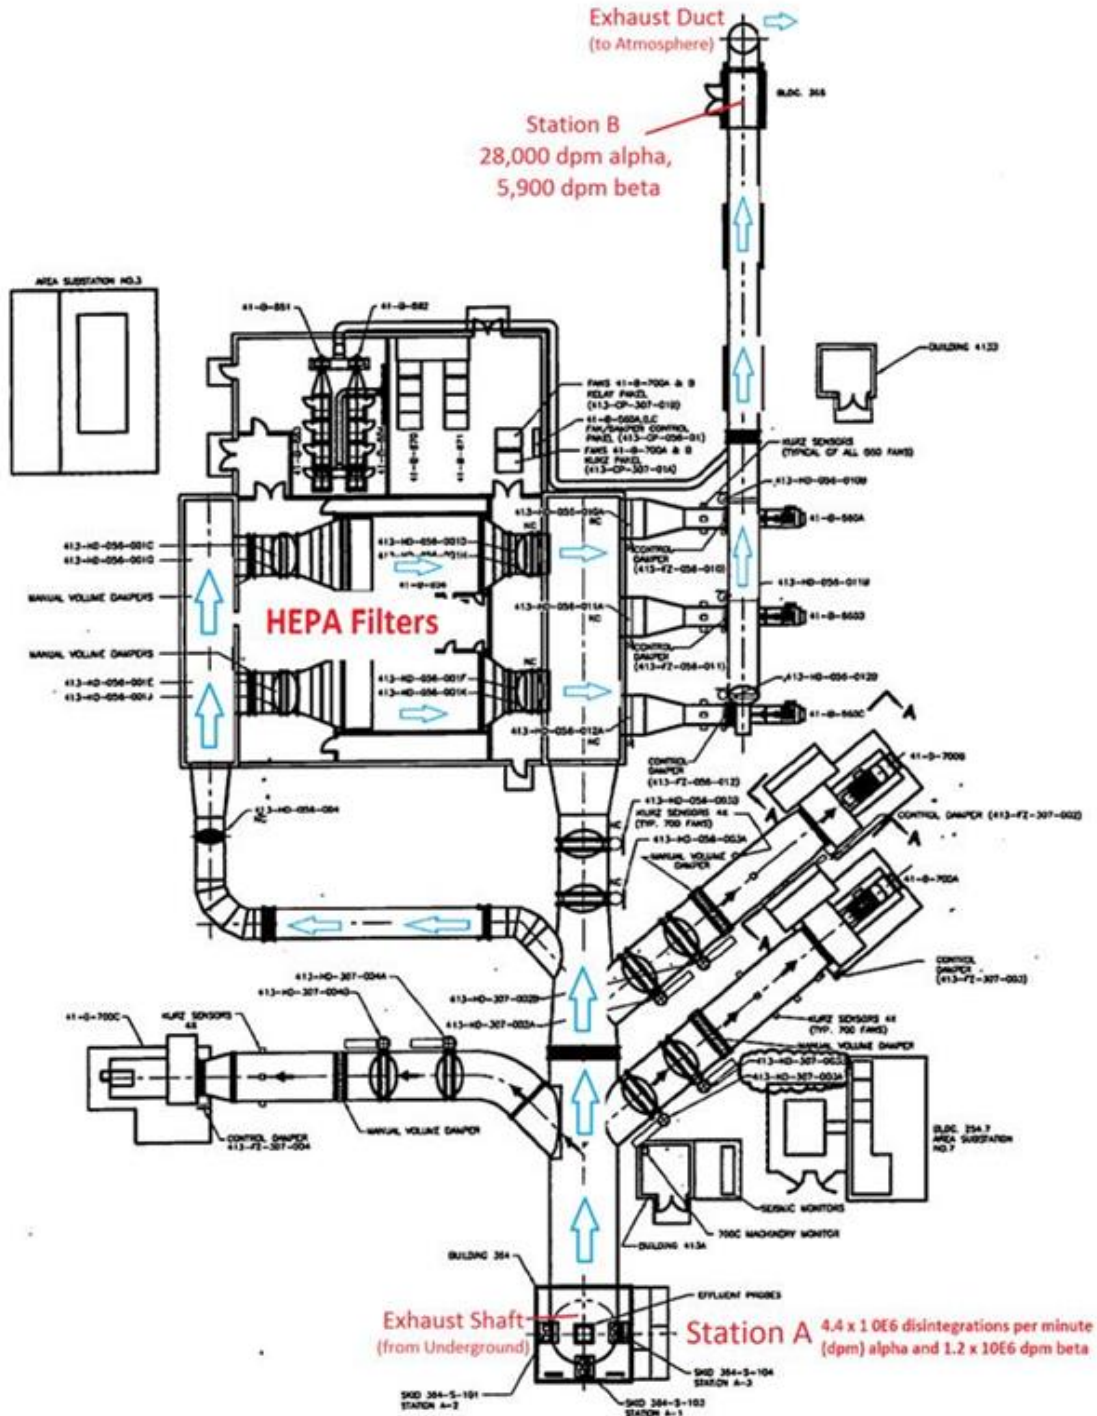
Figure 18: Exhaust Filter Building Ventilation Components Plan View

With regard to ventilation system design and operability: the filtration portion of the ventilation system has two HEPA filter bypass isolation dampers that provide a pathway of unfiltered exhaust into the environment. These isolation dampers are not suitable as a containment boundary and reduce the overall efficiency of the HEPA filter system. This is discussed further in Chapter 9, Underground Ventilation. This condition was never identified by the contractor, CBFO, or Headquarters in any of the revisions and updates to the WIPP safety basis documentation.

The exhaust fans serving the underground ventilation are located on the surface. A combination of six fans provides airflow for the U/G ventilation system. Three large main (700) fans rated nominally at 260,000 cfm discharge directly to the atmosphere. Three smaller 860 fans, rated nominally at 60,000 cfm, draw ventilation through HEPA filtration and discharge to a small stack monitored for radiological release. The 860 fans can also exhaust the underground directly through a filtration bypass duct. (Figure 18 and Figure 19)

On March 6, two ventilation system dampers that were known to have design leakage, and allowed a portion of the radioactive material to bypass the HEPA filters were sealed with a high-density foaming material.
