## Accident Investigation Report

## Underground Salt Haul Truck Fire at the Waste Isolation Pilot Plant February 5, 2014

March 2014

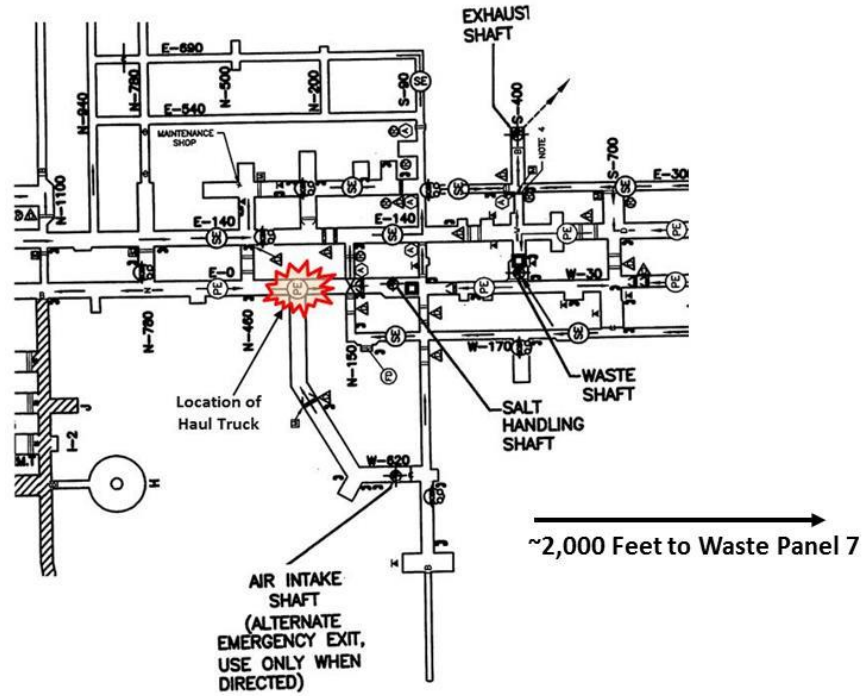
Figure 3: Location of the Haul Truck during the Fire

The WIPP underground consists of the waste disposal area, construction area, north area, and Waste Shaft station area. The location of the accident is shown in Figure 3.

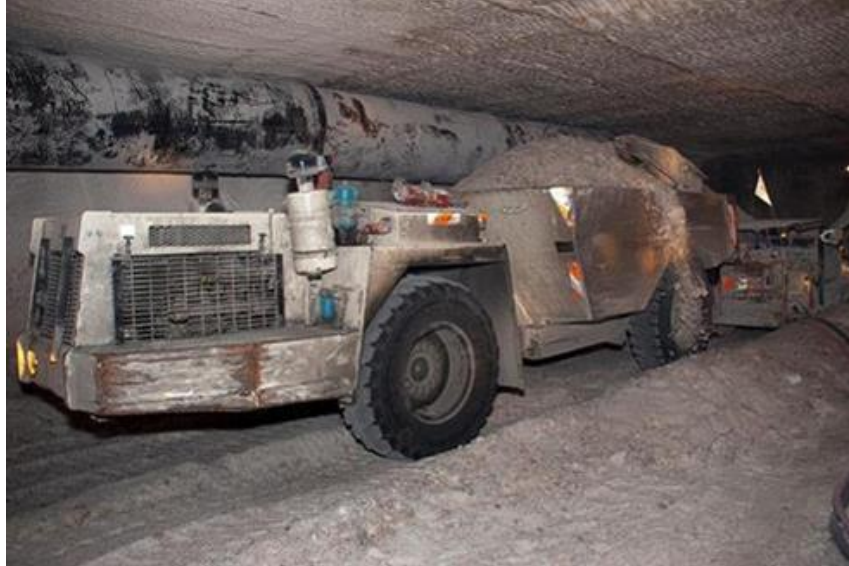
**Figure 4: EIMCO 985T 15 Haul Truck (74-U-006A)**

EIMCO Model 985T-15 haul truck 74-U-006B was purchased in May 1985 and has been used continuously over the past 29 years to transport mined salt to the salt hoist for removal from the underground. A second Model 985-15 salt haul truck 74-U-006A is also in operation in the mine. Figure 4 is a photograph of a Model 985 haul truck (74-U-006A)

The truck has a capacity of 15 tons and is powered by a Deutz V-8 air cooled diesel engine. The truck is equipped with a remote-mounted three-speed (in both forward and reverse) Clark powershift transmission, engine-mounted torque converter, and four-wheel drive with planetary gear wheel ends and integral liquid-cooled brakes. Two 12 volt DC batteries provide electrical power to the vehicle.

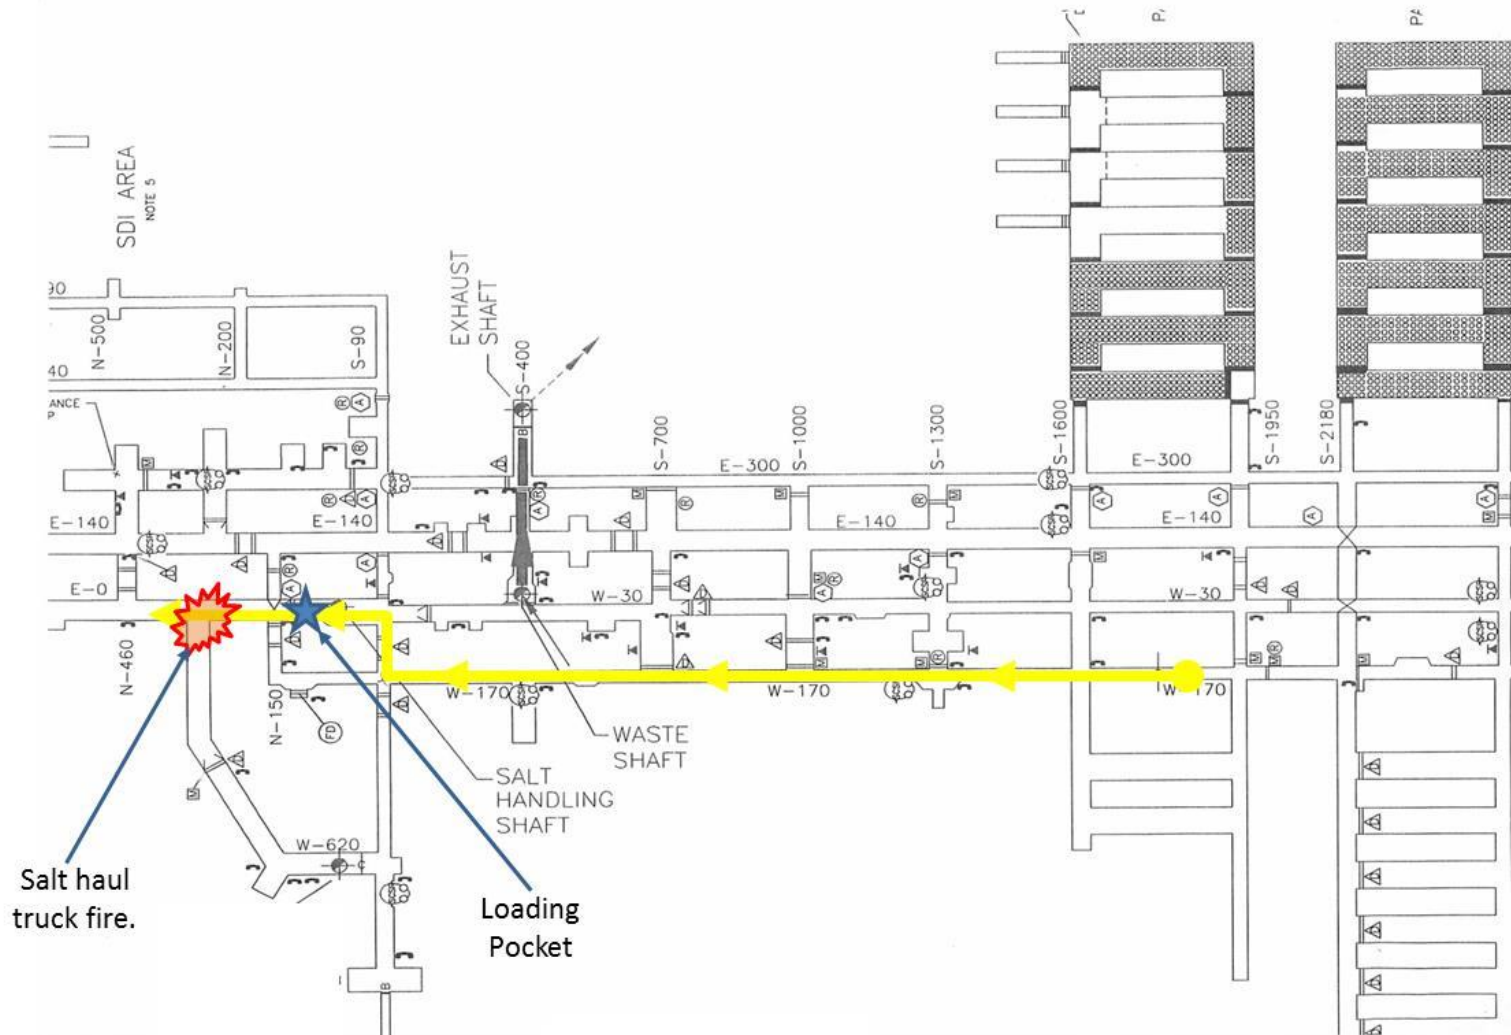
Figure 8: Route of Haul Truck from Panel 8 to Accident Scene

An Operator picked up a load of salt using haul truck 74-U-006B at Panel 8 at approximately 1045 and headed north on W-170 toward the loading pocket (Figure 7) to dump the load. Figure 8 shows the Operator's route from Panel 8 to the scene of the fire. He turned right on S-90, left on E-0, dropped half of his load at the loading pocket, continued north in E-0, and passed N-150 to drop the rest of his load. The Operator pulled into N-300, backed up into E-0, and unloaded the rest of the truck. As the Operator lowered the bed, he looked back to see if it was clear of muck. It was at this point that he noticed an orange glow and then flames between the engine and the dump sections of the truck.

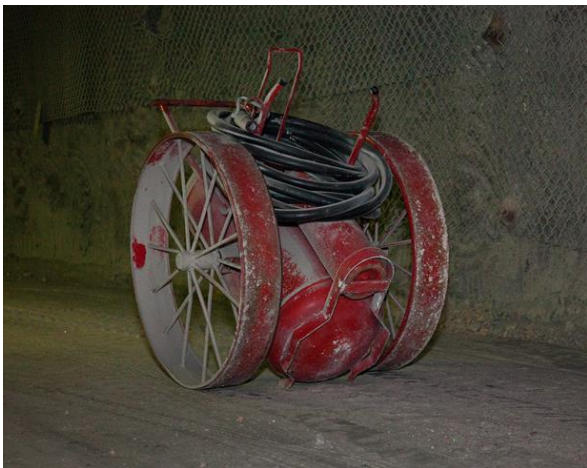
**Figure 11: 300-Pound Extinguisher in the Underground**

The two U/G Services workers attempted to push a 300-pound wheeled fire extinguisher (see Figure 11) to the airlock at E-0/N-150. When the workers opened the airlock, their ITX (carbon monoxide) monitor alarmed and the smoke worsened. The Operator's supervisor (after notifying his room closure crew and the Mine Manager of the fire)

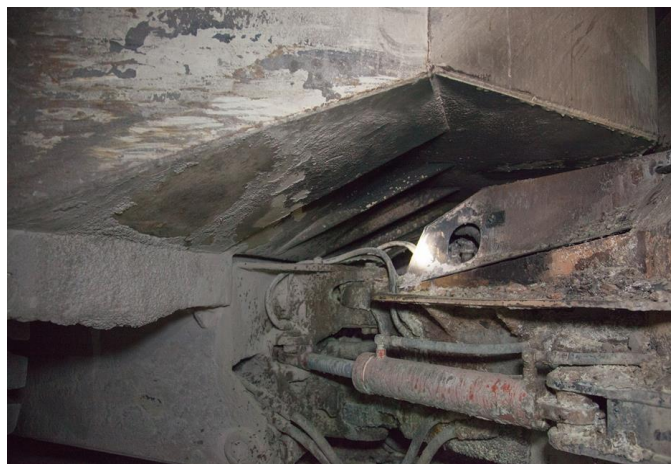
**Figure 20: Transmission Fluid Stick Access**

1043) and was recognized by the truck Operator at 1048. The Operator shut down the engine, exited the hauler on the left side, and moved to the right side. The Operator then discharged his hand-held fire extinguisher through the transmission access hole, which is forward of the pivot pin (see Figure 20) and under the haul truck. Because the fire was enclosed, using a handheld fire extinguisher was ineffective. The delay between initial ignition and activation of the engine compartment fire suppression system resulted in development of multiple leaks.

When the Operator had discharged the hand-held fire extinguisher, he returned to the left side of the haul truck to initiate release of the on-board fire suppression system. The effectiveness of suppression system is uncertain. At activation, the fire could have been too severe to control, or if initially controlled, a hot surface within the engine compartment might

have reignited the fire. When the engine was shut down, the cooling fan stopped. Because of the haul truck orientation, mine ventilation flow was opposed to the cooling system airflow. This prevented further propagation towards the rear of the haul truck and prevented ignition of the rear tires. The change in engine compartment airflow direction also created a V-shaped discoloration on the haul truck grill. This discoloration was created by the most intense flaming. Sooty deposits occurred on either side of this V where the flames were less intense.
